AN EXPERIMENTAL STUDY OF FACTORS
AFFECTING CURRENT FLOW AND SEDIMENT
STABILITY ON THE FORT ANNE FORESHORE

Canadian Parks Service,
Environment Canada
Contract No. HS/SWNS 93-01

Acadia Centre for Estuarine Research,
Acadia University, Wolfville, Nova Scotia B0P 1X0

September 1993

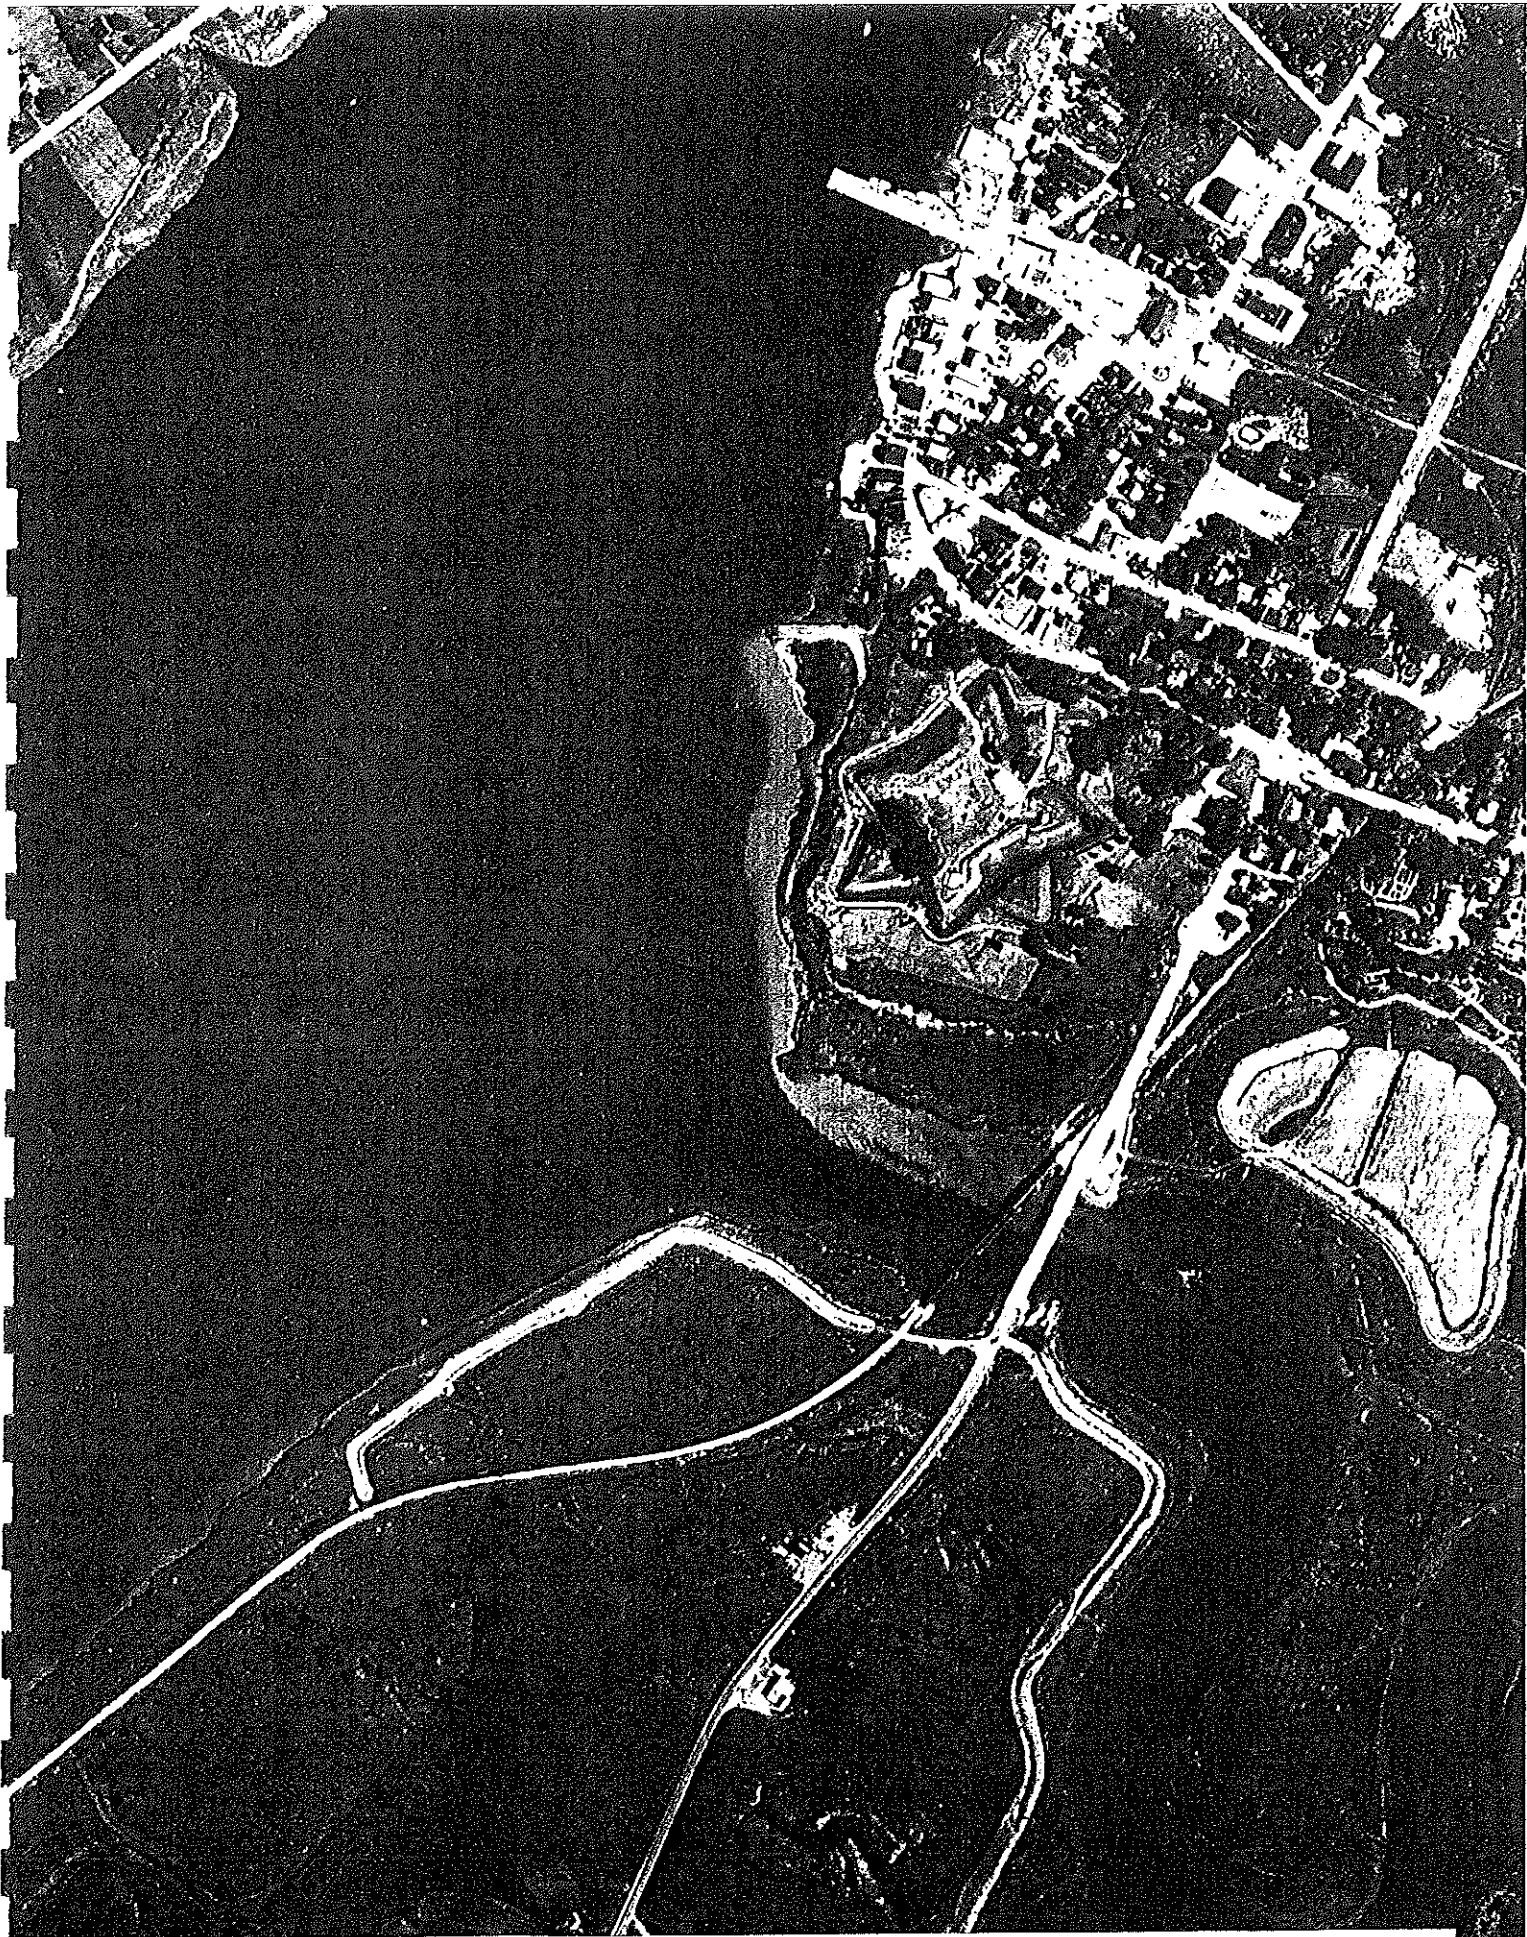
Figure 1. Aerial photograph showing turbid plume entering Allain River from resuspension on Fort Anne shoreline, 13 August 1992.

By 12:00 h, at an early stage of the flood, it was apparent that water advancing over the Fort Anne shoreline was very much more turbid than the rest of the flooding water, because of immediate resuspension of clays from that shoreline. This resulted in a distinct turbid plume that passed into Allain River as a narrow band along the eastern shore, constrained there by the eddy described above. The plume never intersected the location of the CTD, which was suspended from the middle of the road bridge. These phenomena precisely match the conditions recorded in an aerial photograph taken on 13 August 1992 (see Figure 1).

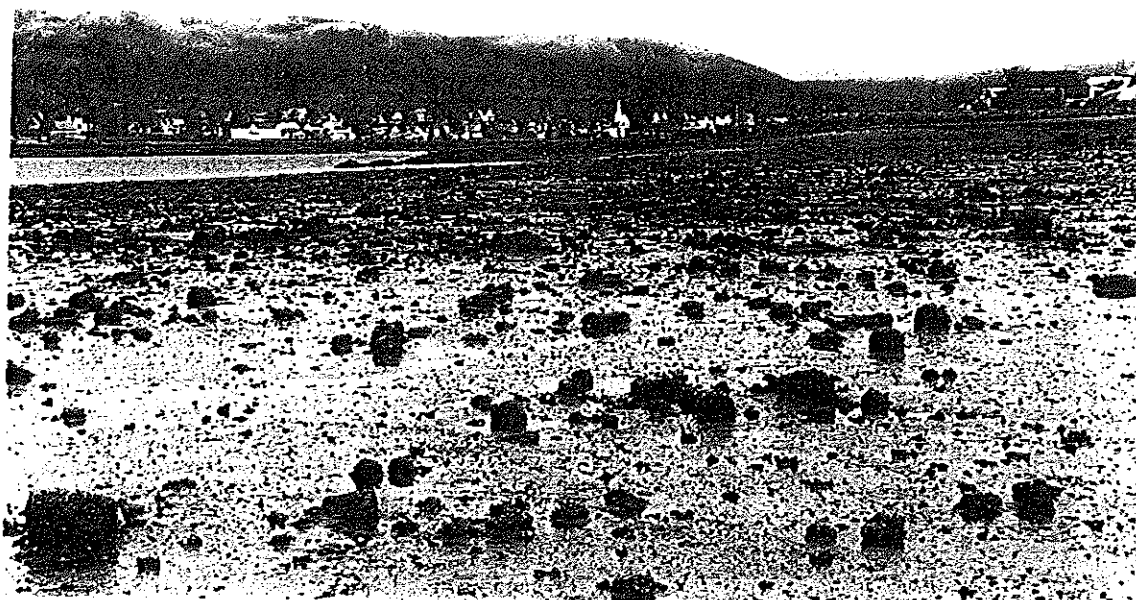
Figure 2. Fort Anne shoreline looking north showing exposed red clay and boulders from exposed embankment foundations.

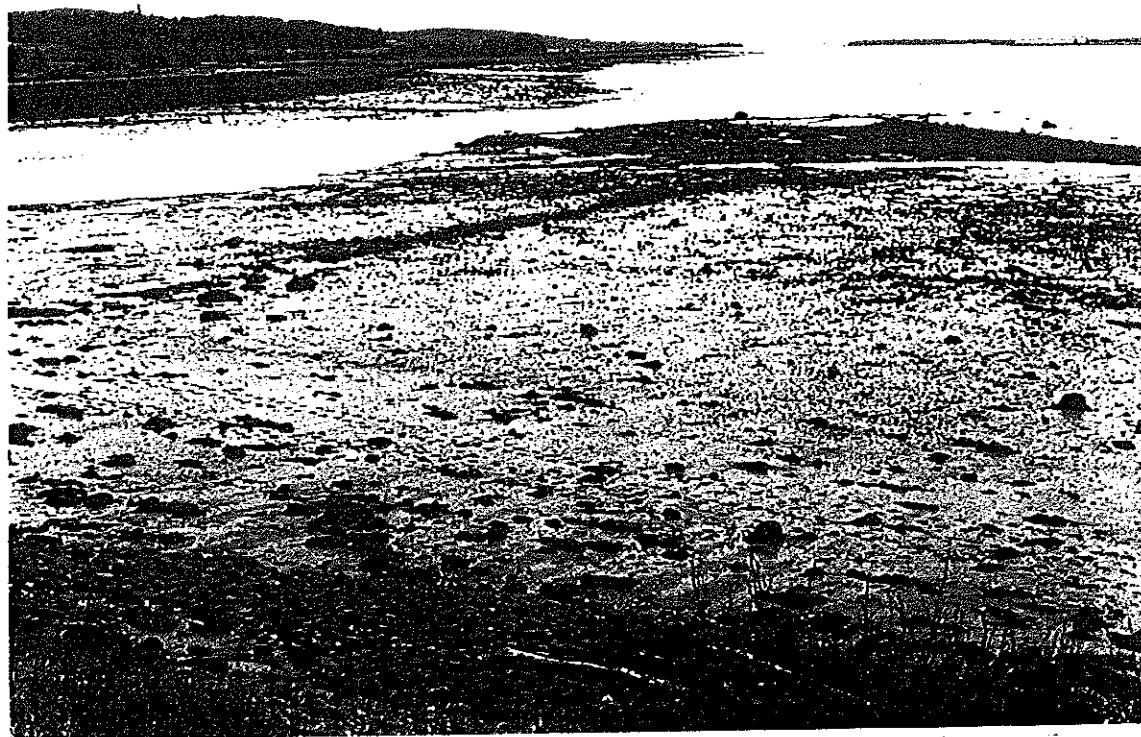
Close examination of a 1981 aerial photograph showed that in the past a linear structure had extended from the fort to a rocky point in the mouth of Allain River. This structure is represented now by a distinct band of rocks visible as a dark line extending from the rocky point toward the saltmarsh in Figure 3. It was hypothesised that a wharf or seawall in this

Figure 3. Fort Anne shoreline looking west toward point showing line of boulders from previous construction, and exposed cribwork in right foreground.

location might have had the effect of reducing any northward flows of water across the fort shoreline, and might therefore have provided a protective function for the fort walls.

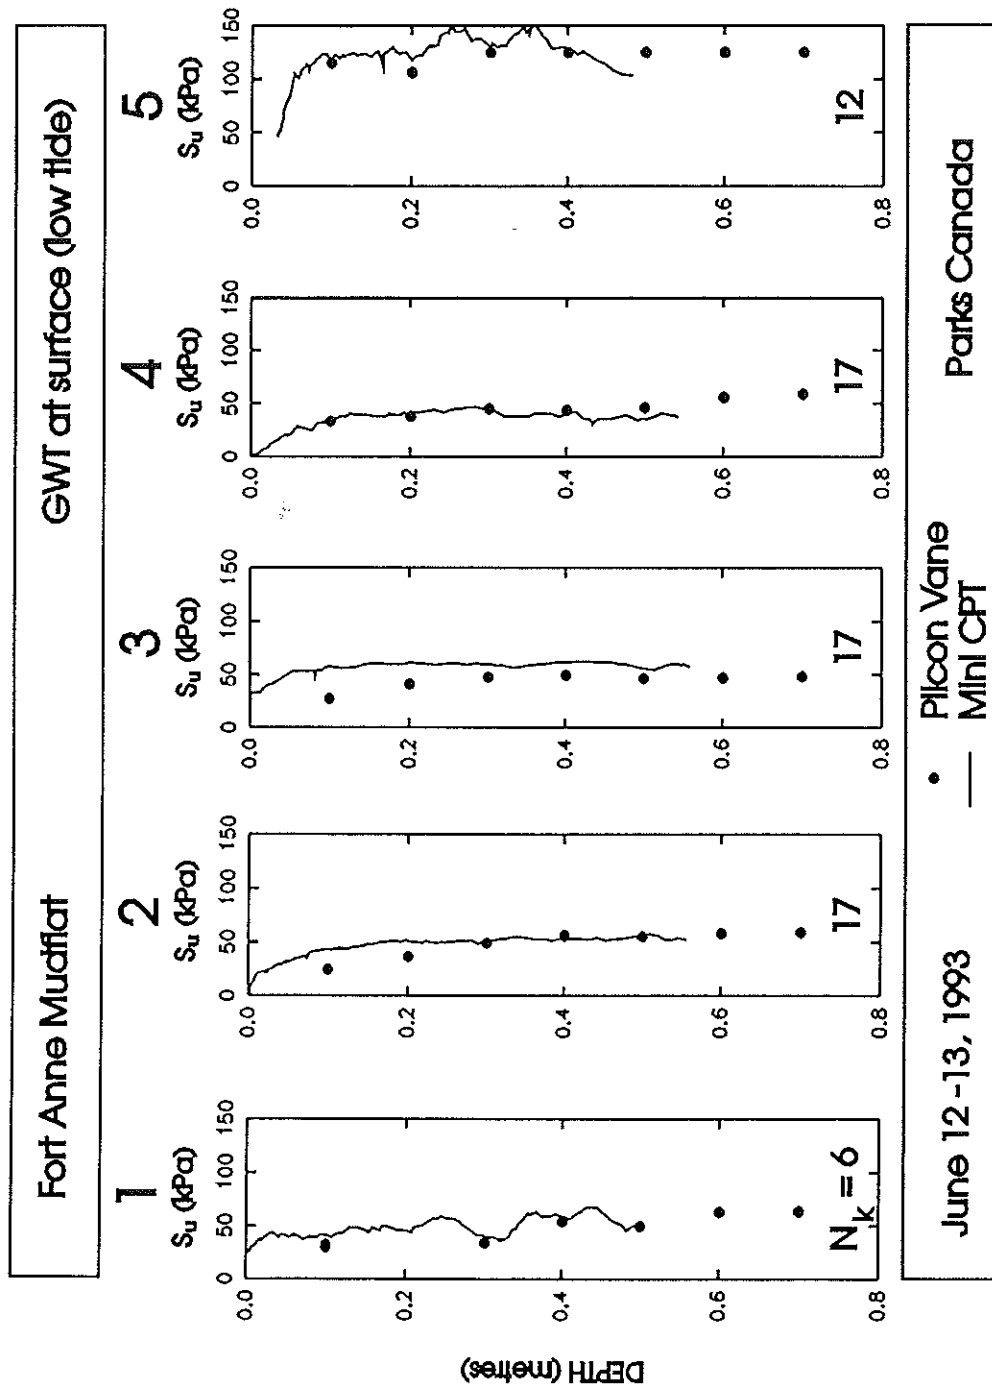
Measurements of sediment strength using a Pilcon vane and a miniature cone penetrometer were made at 5 sites, including the two borehole sites. Results are shown in Figure 5. There was a thin veneer of softened clay at the surface of the mudflat, presumably derived from wetting of the exposed clay. Wetting gradually removes cohesion, a process known as 'softening', after which resistance to erosion becomes minimal. Cone penetrometer measurements show that below the surface the sediment is highly overconsolidated, indicating that it has been preconsolidated under a higher overburden pressure in the past. The degree of overconsolidation recorded is consistent with what would exist from the erosion of 1 to 1.5 m of overburden at sites 1 to 4, and 3 to 4 m at site 5.

Figure 5. Summary profiles of miniature cone penetration and Pilcon vane tests carried out on the intertidal mudflat at Fort Anne, Annapolis Royal.

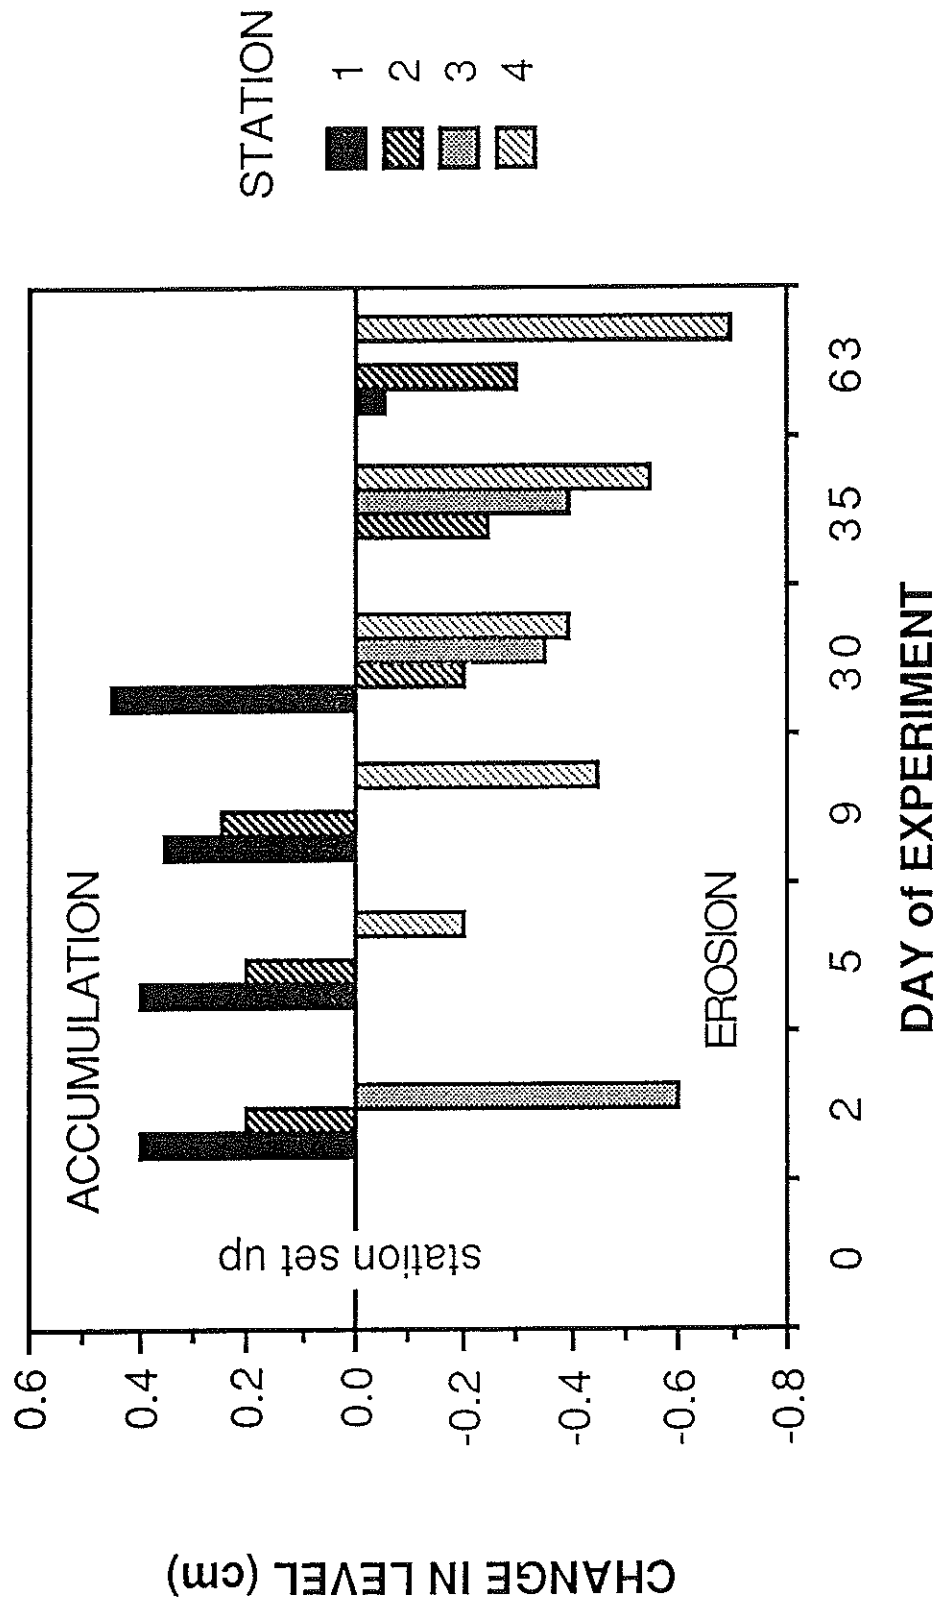
Monitoring of bed levels at the four permanent stations has so far shown little consistent pattern except at the highest level in the intertidal zone. Data are shown in Figure 6. Of the four stations, station 3 on the Allain River side of the barrier is the lowest in elevation, being flooded approximately 45 minutes before station 1, and an hour before station 2. Initially, station 3 lost sediment, but its level remained constant while the barrier was in place; with the barrier removed, it appeared that erosion was again dominant, approximately 4 mm having been lost by the end of June. (The station was inaccessible on 27 July.) At station 1, the second lowest and most easterly site (i.e., furthest removed from the barrier), there was a steady gain of sediment, amounting to 7.5 mm over the first 35 days of record, but by the end of July (day 63) this accumulation had been lost. At station 4, which is highest in the intertidal zone, and just near the landward end of the barrier, approximately 5.5 mm was lost by the end of June, and a further 1.5 mm by the end of July. Station 2 has fluctuated between accretion and erosion, gaining while the barrier was in place, and then losing once it was removed.

Figure 6. Changes in bed level at four stations on Fort Anne shoreline. Day 0 = 25 May 1993.

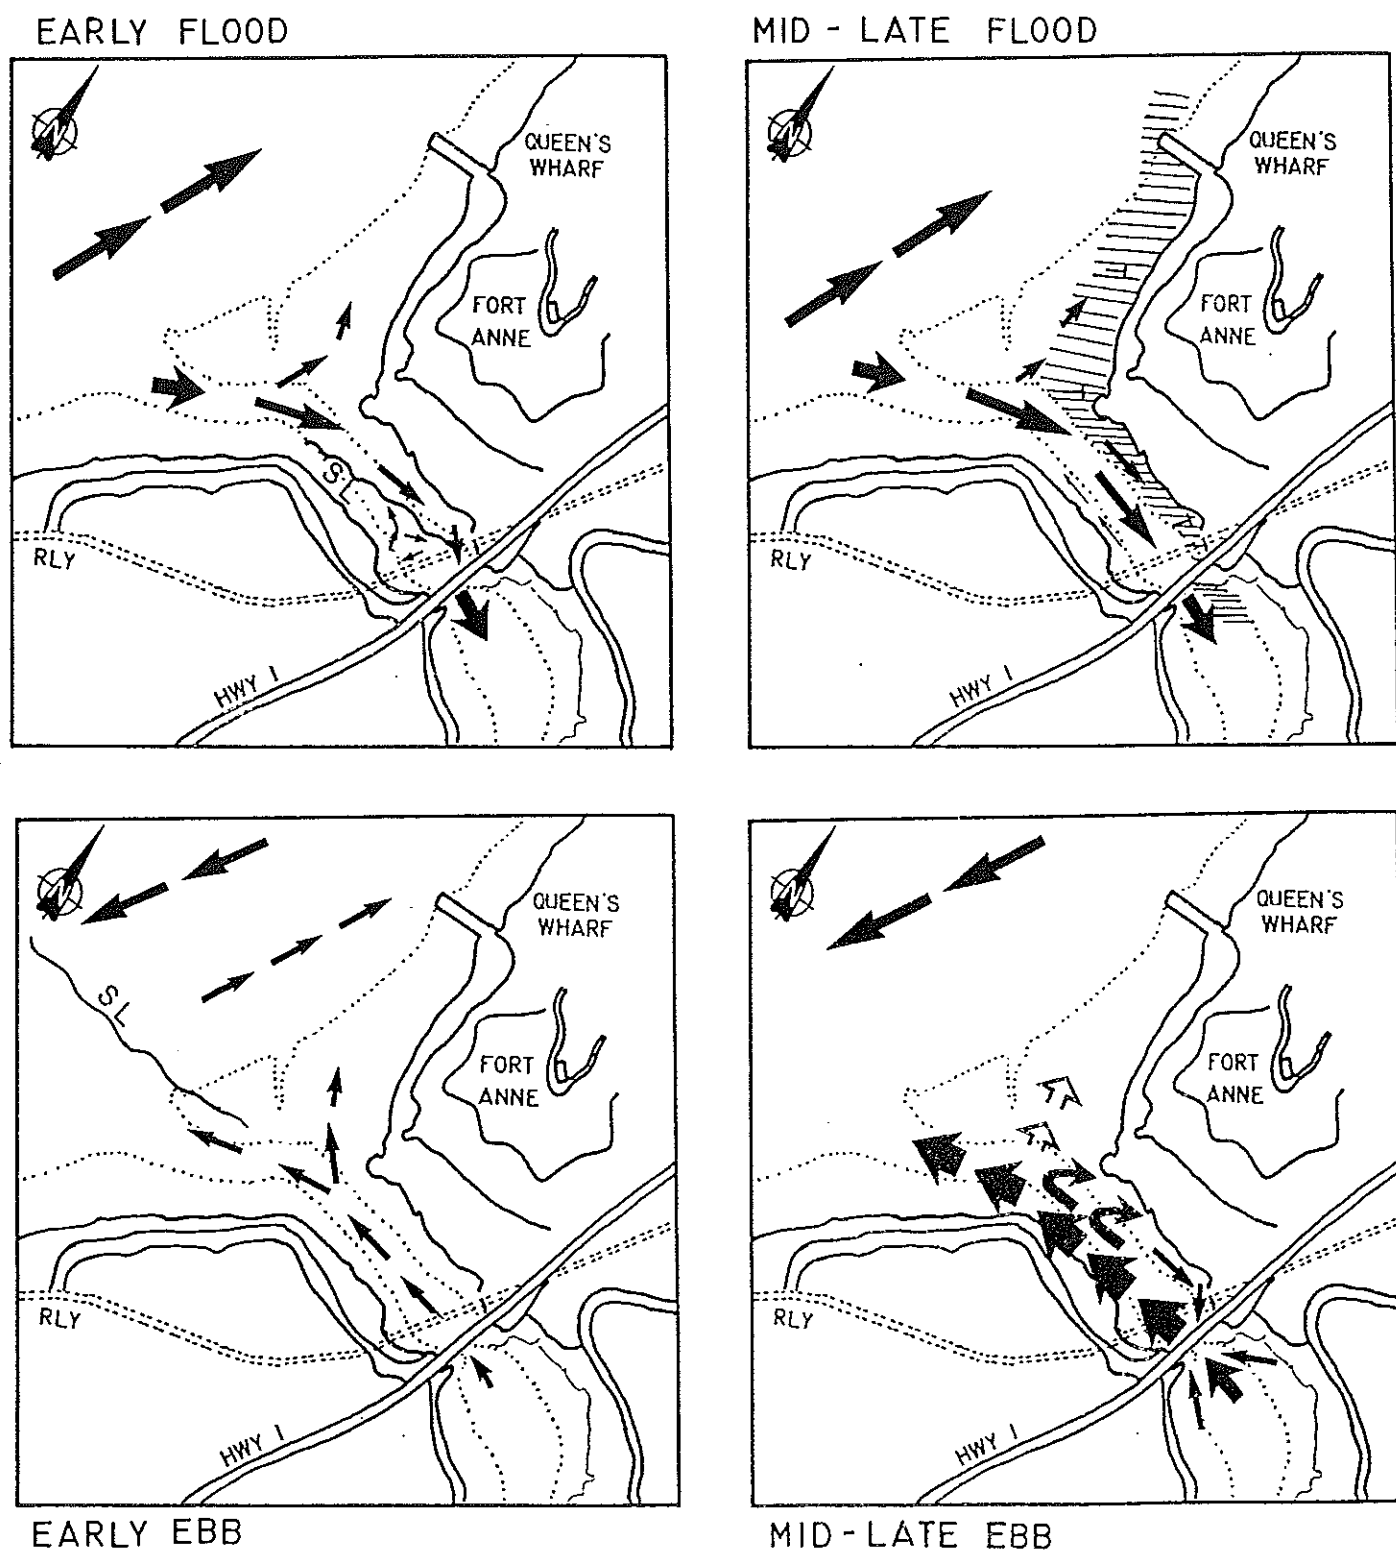
Observations made during these measurements indicate very strongly that the pattern of flow through the bridge over Allain River has a great deal of influence upon the flows across the Fort Anne shoreline. The pattern of flow during the early flood results in formation of a shear line running diagonally across the river channel between the southwest shore at the mouth of the river, and the eastern shore of the river at the level of the railway bridge. Associated with this shear line is a major clockwise eddy that constrains water advancing into Allain River to follow the eastern side, i.e., beside Fort Anne.

During the ebbing tide, flow was maximal toward the western side of the channel, and resulted in formation of a major clockwise gyre or eddy that maintained at least a surface flow toward the Fort Anne shore. At its most extreme development, just before the study was concluded, outflow from the Allain River was strongly concentrated on its southwestern side, with a backward, or upstream flow on the northeastern side resulting from the gyre.

Figure 13. Patterns of current flow in Allain River. T = turbidity plume, SL = shear line.

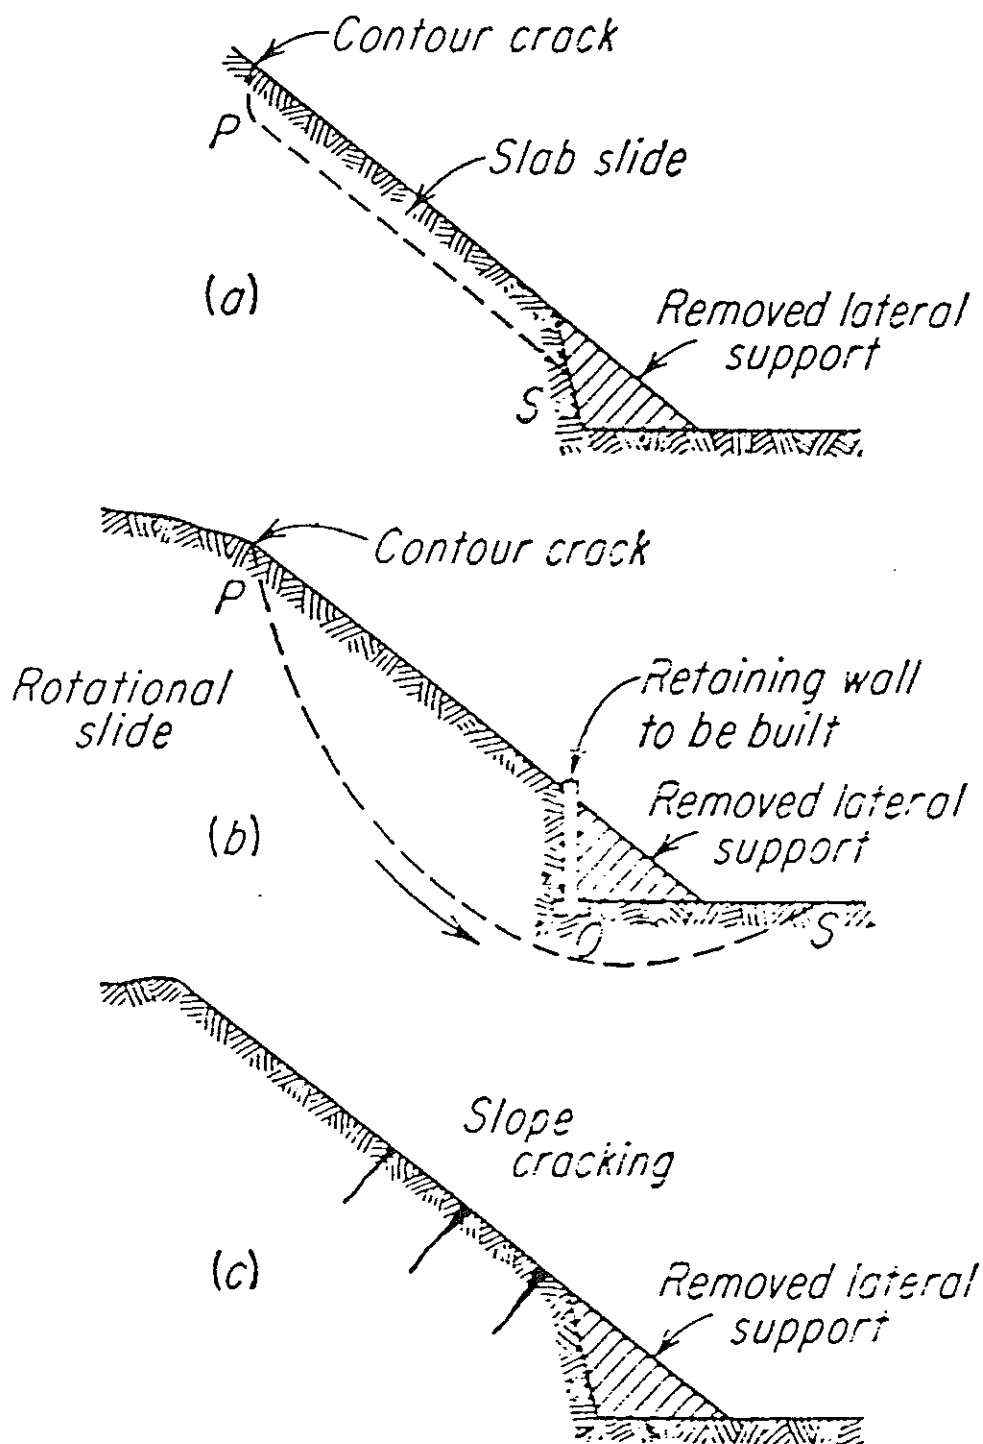
Nonetheless, all indications are that the embankment is unstable, and that the absence of a sufficient mass at the toe of the slope is part of the reason. Present stratigraphic information suggests that the fort may be underlain by a plastic clay that seems to have sufficient strength to support the embankment as long as it remains intact and unweathered. Permitting the present disintegration of the embankment may well lead to intrusion of water into this layer and hasten its failure.

Figure 14. Sliding caused by the removal of lateral support.
