**Environmental Studies of the
Halfway River System
Nova Scotia**

Final Report
to
Minas Basin Pulp and Power
Company Limited

September 2001

Acadia Centre for Estuarine Research
Publication No. 62

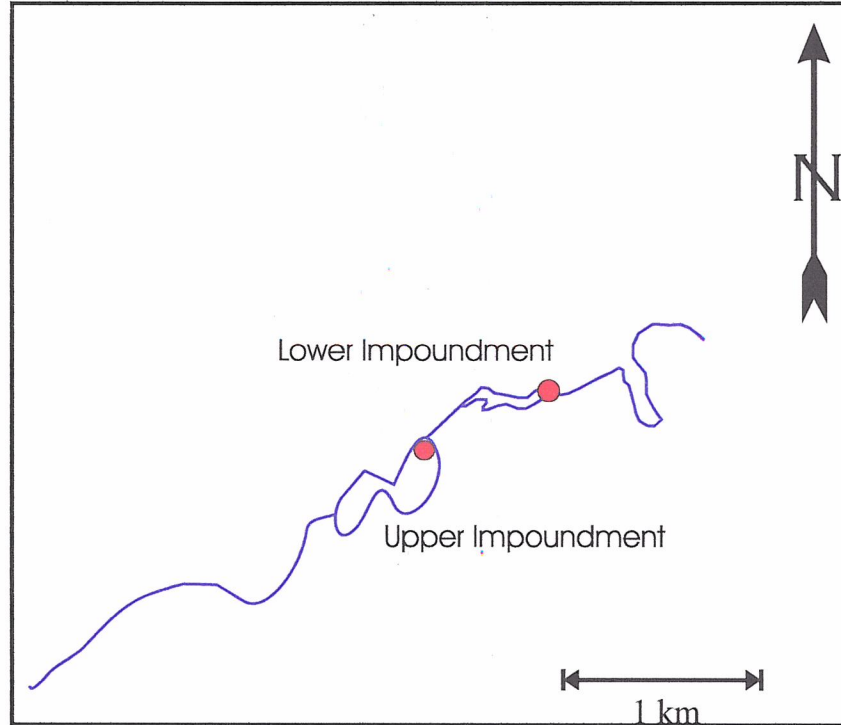
Figure 3.2.1. Location of water quality sampling stations in Halfway Impoundments.

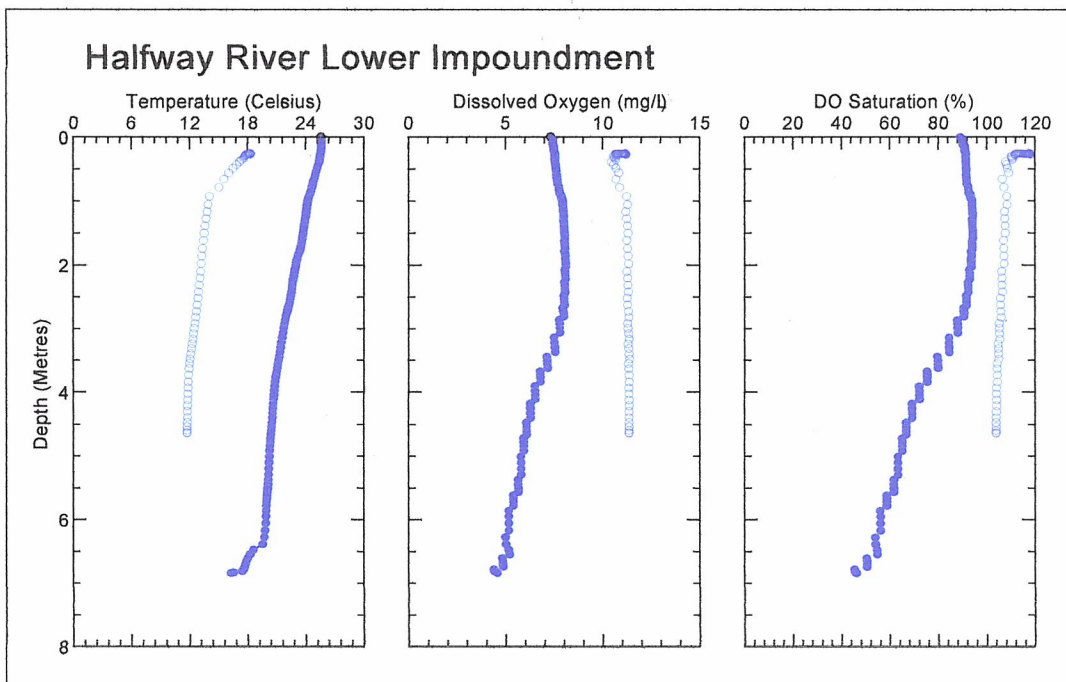
Figure 3.2.2. Temperature, dissolved oxygen and percent dissolved oxygen depth profiles for the lower impoundment during spring (◇) and summer (●).

Depth profiles of dissolved oxygen and percent dissolved oxygen saturation (Figures 3.2.2. and 3.2.3) indicate that the lower water column of the Upper Impoundment showed signs of dissolved oxygen depletion as early as 24 May. The Lower Impoundment showed little change in dissolved oxygen with depth during this period. By mid-summer (16 July), the Lower Impoundment exhibited some oxygen depletion within the lower water column, but never became anaerobic. In contrast, the hypolimnion of the Upper Impoundment was nearly anaerobic.

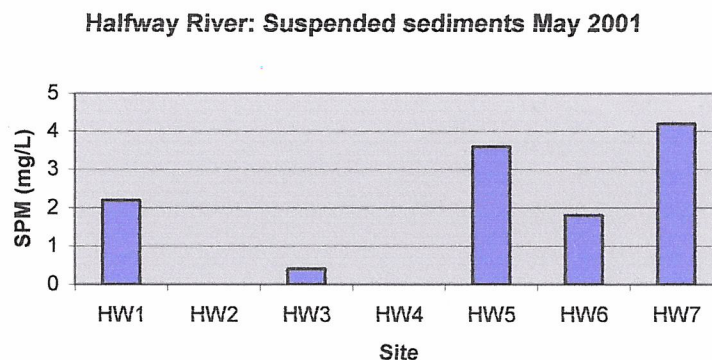
Figure 3.2.4. Suspended sediment concentrations at Halfway River sites, May 2001.

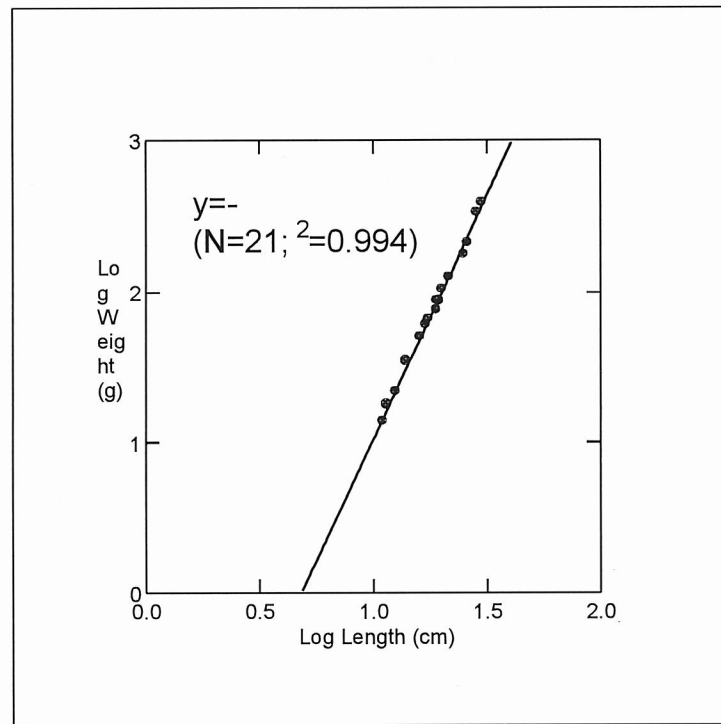
Figure 3.3.2 Length-weight relationship for brook trout collected from the Upper Impoundment.

The length-weight relationship of brook trout collected from the Upper Impoundment is shown in Figure 3.3.2. The regression coefficient in excess of 3 indicates that the trout collected were in good condition.

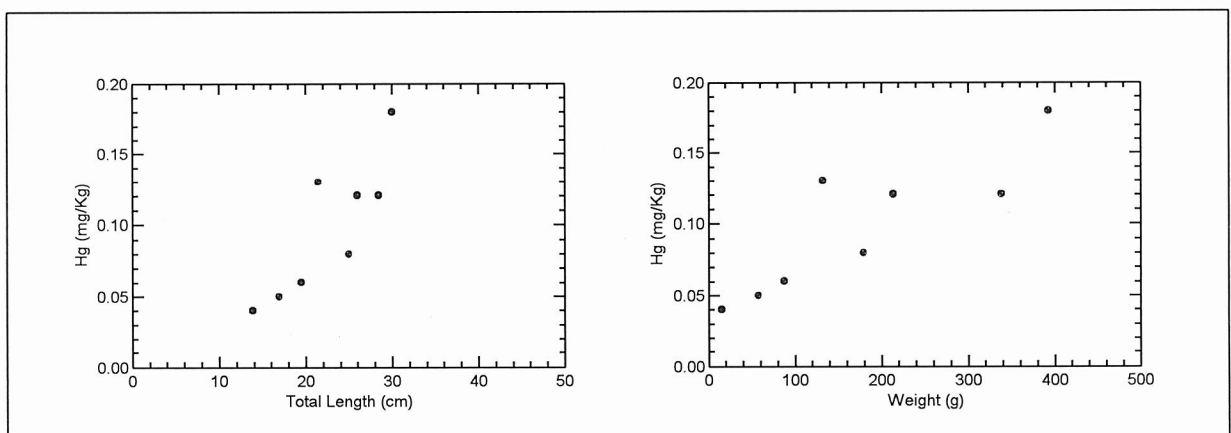
Figure 3.3.3 Relationship between mercury content and size for brook trout collected from the Upper Halfway River Impoundment.

The mercury content of eight brook trout collected from the upper impoundment ranged between 0.04 and 0.18 mg Hg/kg wet weight. These values are well below the Health Canada guideline of 0.5 mg Hg/kg and are about average for Nova Scotia brook trout. A survey of brook trout collected from lakes throughout Nova Scotia carried out by the Nova Scotia Department of Environment (1994) found an average and range of 0.18 and 0.03-0.26 mgHg/kg wet weight respectively. Similar averages and ranges have been reported for brook trout collected from Kejimikujik National Park, N.S. More relevant to the Halfway system is a study carried out by Nova Scotia Power Inc. (1995) on ten lakes and reservoirs associated with hydropower systems. Twenty-five brook trout were sampled from 10 lakes and reservoirs. The average and range of mercury levels was found to be quite high, 0.51 and <0.4-1.68 mg Hg/kg respectively.

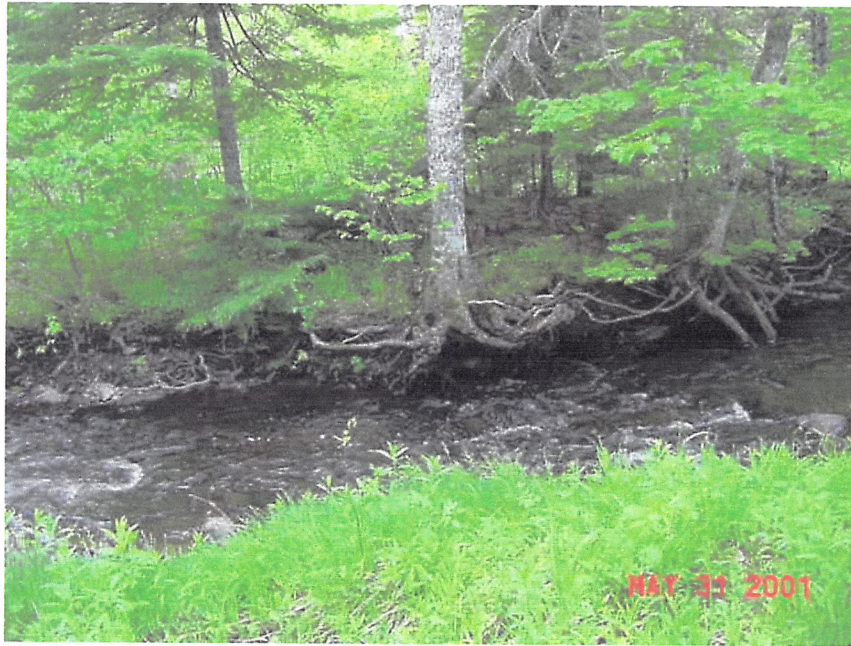
Figure 3.3.5. Halfway River Site 1.

This site (Figure 3.3) is on the main stem of the Halfway River approximately 150 m below the waterfall at Greenfield. Sampling length was 58 m, with a wetted width of 4-5.7 m. Riparian vegetation is principally hardwoods (Maple, Birch), and provides 30-50% cover. Substrate is variable, primarily cobbles and boulders interspersed with slate outcrops that create both turbulent flow and calm areas below larger rocks. There is very little fine sediment in the bottom, attesting to the vigorous flows at some times of the year, and very limited habitat suitable for spawning of salmonids. Rocky substrates are often coated with mosses, especially on the downstream faces.

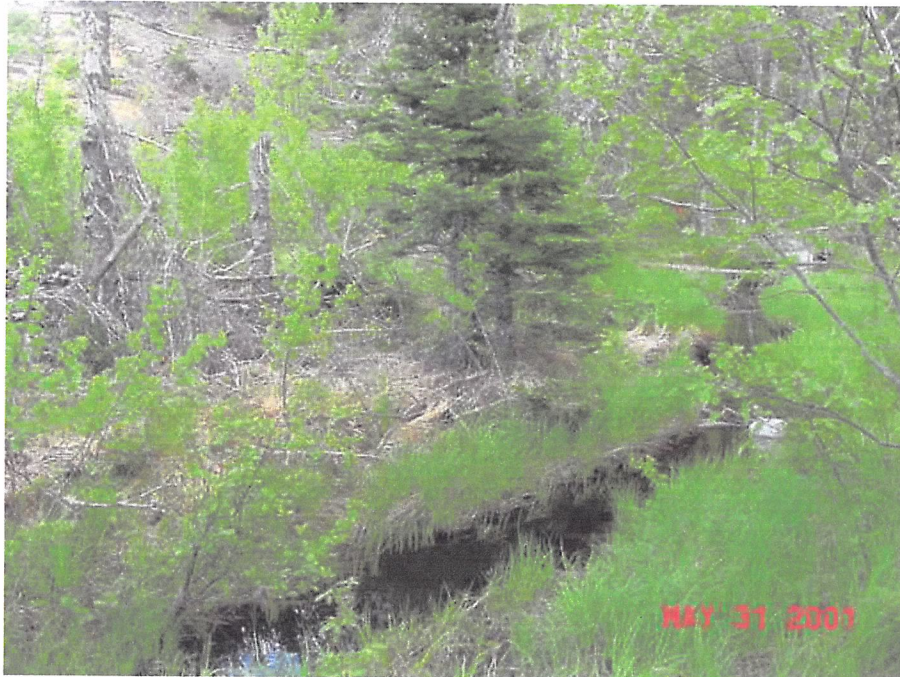
Figure 3.3.6. Halfway River Site 2. Fielding Hollow Brook. View downstream.

This site is on a tributary that issues from Peck Meadow, and enters the Halfway River just downstream of HW1. The site began at a culvert and ended approximately 100 m downstream. Vegetation is very dense on either side of the channel, which varies in width from 1-2 m, and consists of approximately 50% alders and 50% grasses. There were several deadfalls and extensive vegetation overhang and cover for 85-90% of the channel. Substrate was fine sediment, principally sand, but with large amounts of organic matter. Deep black sediments lay beneath the sediment surface, indicating anaerobic conditions there.

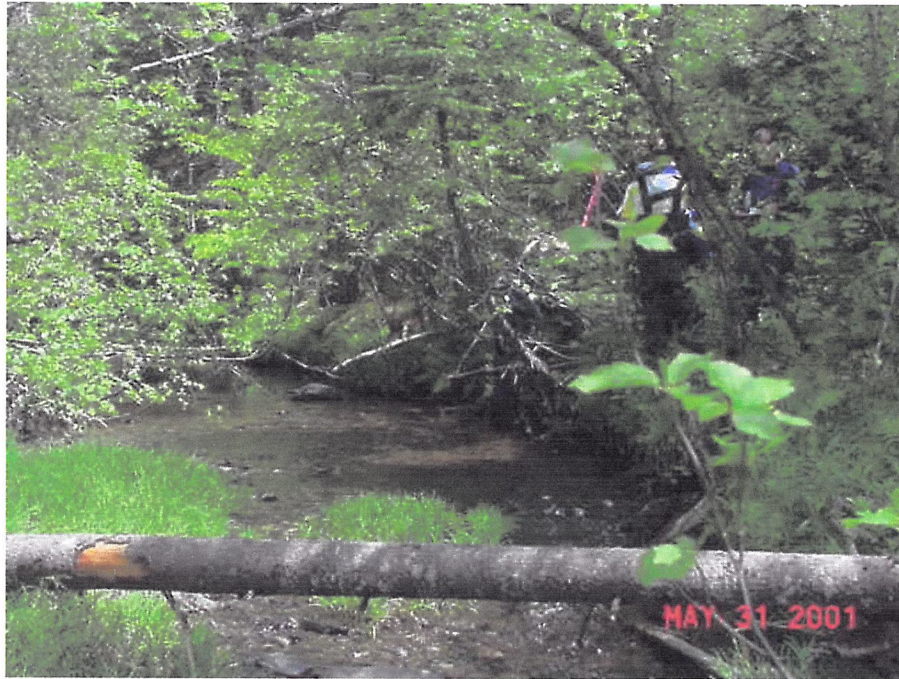
Figure 3.3.7. Halfway River Site 3. Gold Brook. View upstream.

This site (Figure 3.3.7) is on a tributary entering the Halfway River from the north. The reach begins approximately 10 m above the culvert beneath Bishopville Rd., and extends for 51 m upstream. Wetted width was 2-4 m. The stream was almost completely shaded, predominantly from surrounding softwoods. This stream was notably cooler during the spring survey (May) than the main Halfway River on sampling, indicating probable groundwater supply. Substrate was mostly coarse gravel (<3 cm) to cobble (<13 cm), and contains several riffle areas and suitable spawning sites.

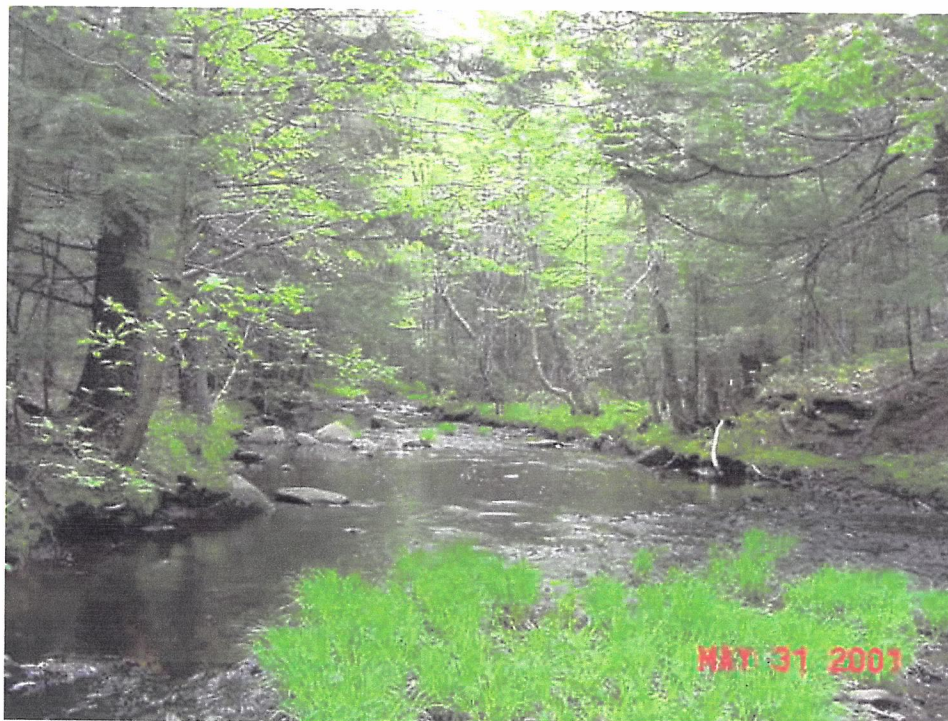
Figure 3.3.8. Halfway River Site 4. Thompson's Brook. View upstream.

The electrofishing site was located approximately 2-300 m above the junction between Thompson's Brook and the Halfway River; reach length was 67 m, and width 4-8 m. This is a broad, shallow stream (Figure 3.3.8), in which the substrate varies from small pebbles to cobble. Most of the reach consists of riffles and runs, with few large rocks or outcrops. Canopy cover varies from 60% to 0% from a mix of hardwood and softwoods; on the north side just below the fish survey site is a low grassy bank, and similar low erodible banks occur at several locations. Between the site and the junction with the Halfway River the stream is braided. This tributary is potentially a good spawning area for trout and suckers.

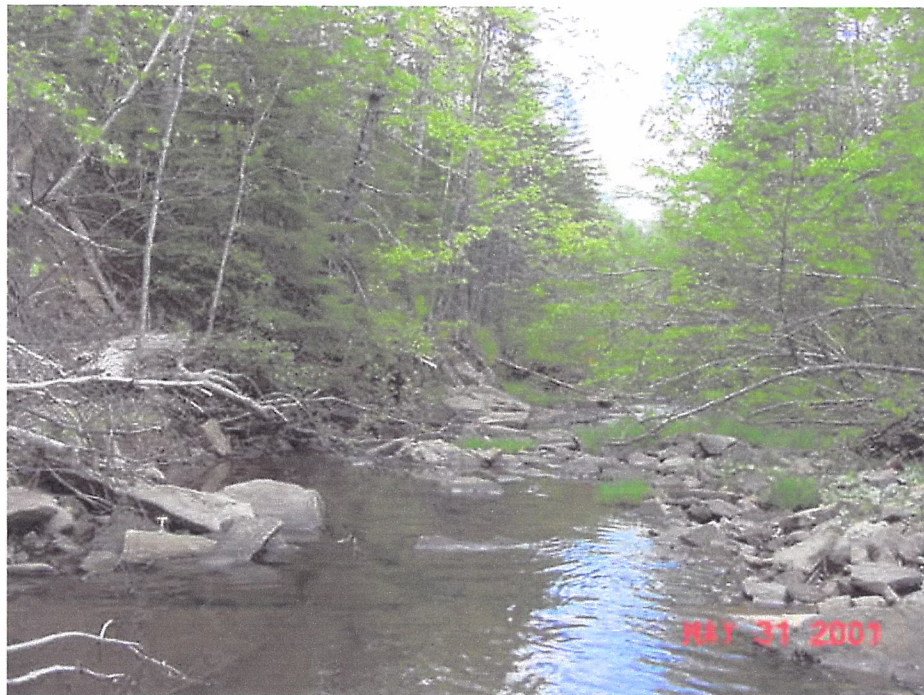
Figure 3.3.9. Halfway River Site 5. Kelly Brook. View downstream.

The sample area on Kelly Brook begins about 30 m downstream of a concrete weir below a culvert under Bishopville Rd. (Figure 3.3.9). This is a shallow, mostly exposed and degraded stream that empties into the Upper Impoundment. Substrate is a mix of bedrock, boulders and cobble, with very little fine substrate, and no obvious suitable spawning sites between the culvert and the reservoir. Riparian vegetation is a mix of softwoods (60%), hardwoods (30%), and alders (10%).

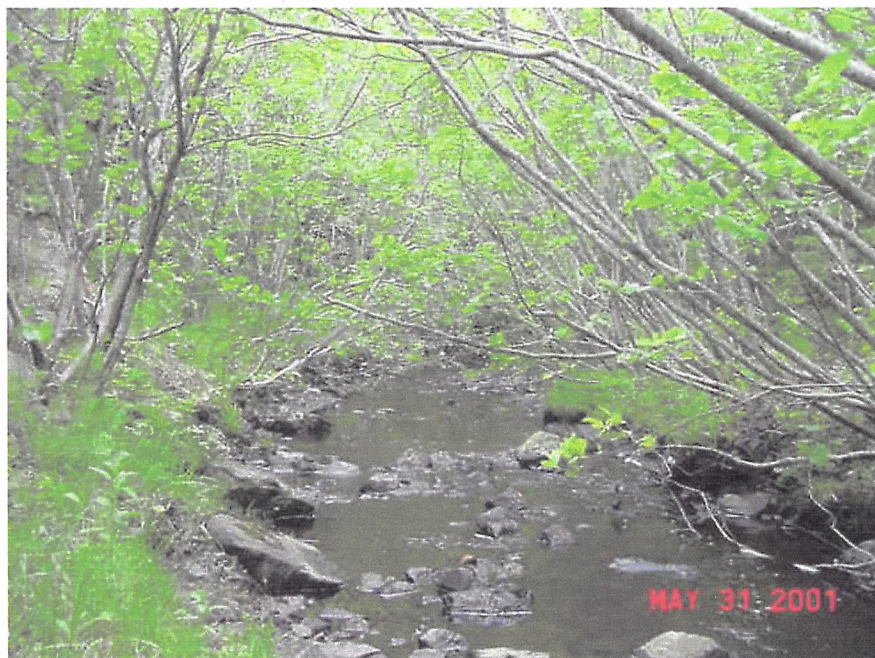
Figure3.3.11 Halfway River Site 7. View downstream.

Because of the obvious impact of the nearby highway, and because this stream is not directly influenced by water management operations of Minas Basin Pulp and Power Company Limited, this site was not sampled during the summer series in July. Instead, another site (HW8) was established on the main stem of the Halfway River. However, the Black River data may represent tributaries that are influenced by the gypsum deposits to be found north and east of the Halfway River watershed.

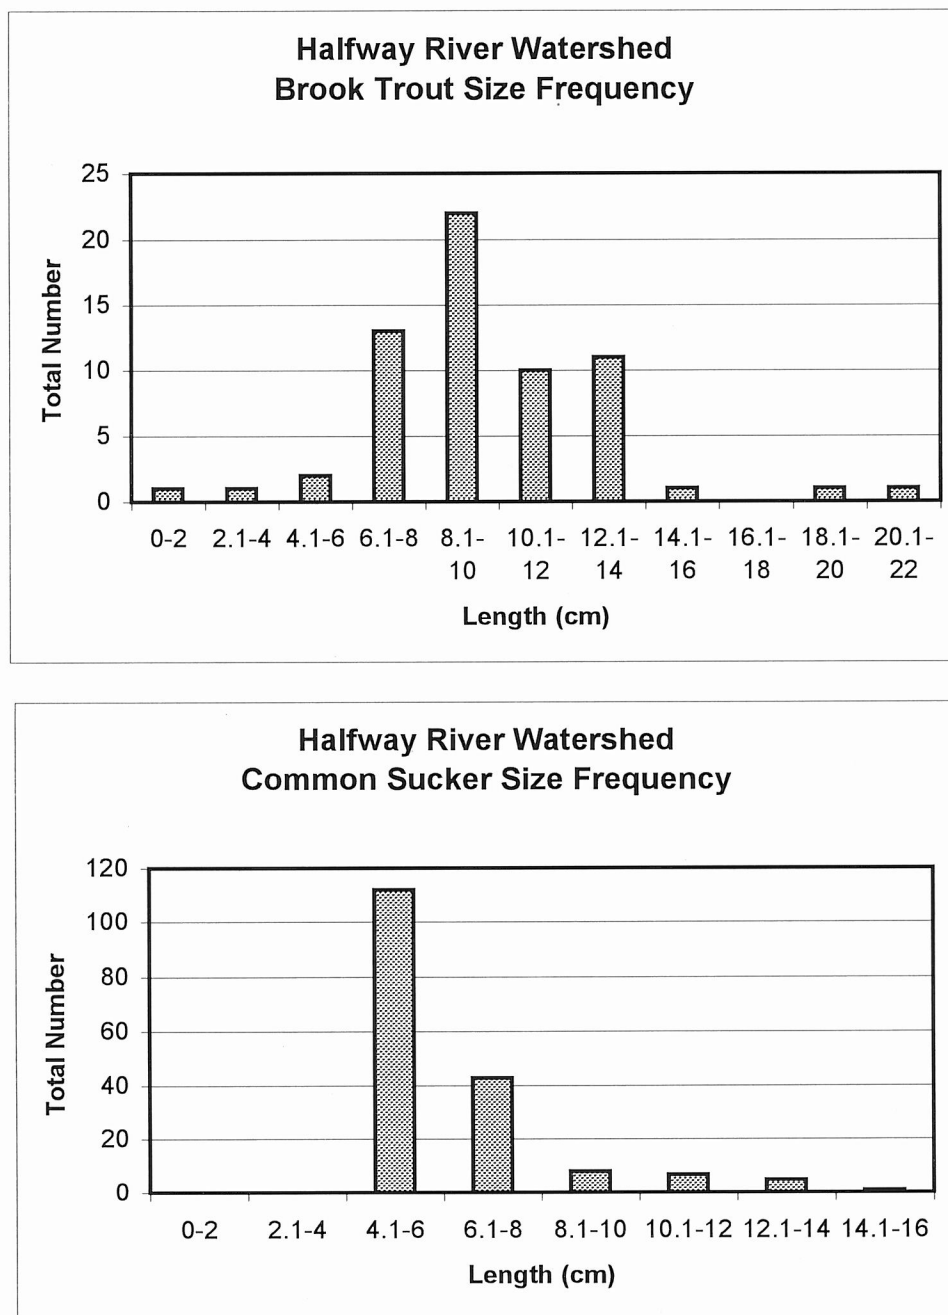
Figure 3.3.13 Size frequency distributions of brook trout and white sucker in Halfway River, May – July 2001

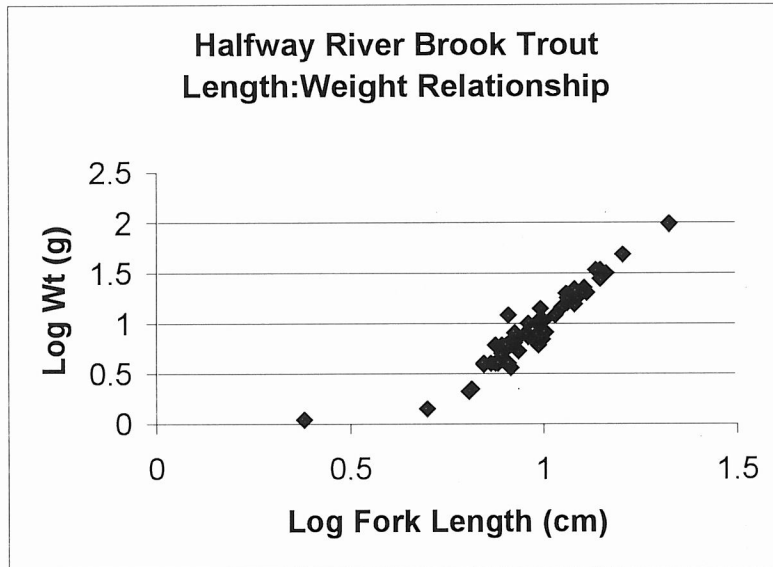
Figure 3.3.14 Length-Weight Relationships of Halfway River brook trout.

The length-weight relationship can be used as an indicator of fish health, but large number of values are needed. There does not appear to be anything exceptional about these results.

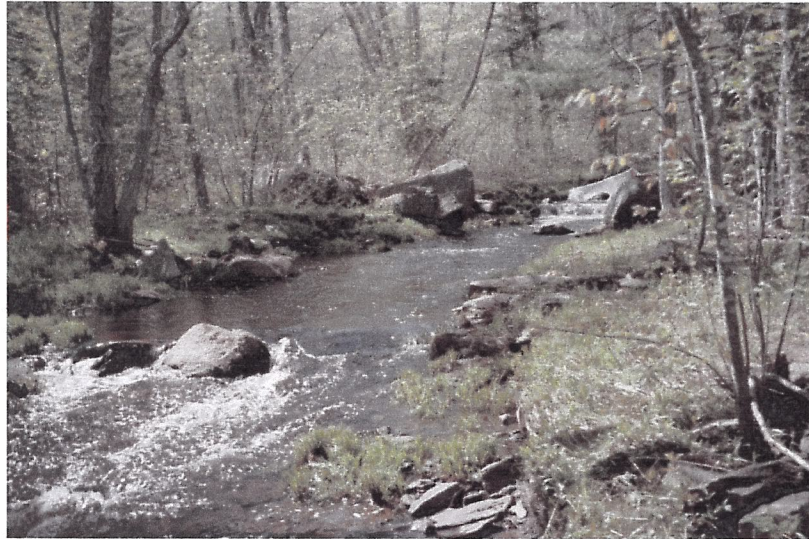
Cover was provided in many places by undercut river banks (cf. Figure 3.3.2) where tree roots continue to hold parts of the bank in place, and where deadfalls occur. Invertebrates were dominated by mayflies and stoneflies (cf. Section 3.6). The combinations of cover, the relatively abundant mosses, insects from overhanging vegetation, and holding areas below larger rocks, makes this stretch of the river a good rearing habitat.

Figure 3.5.1 Upper Halfway Brook showing varied shore vegetation

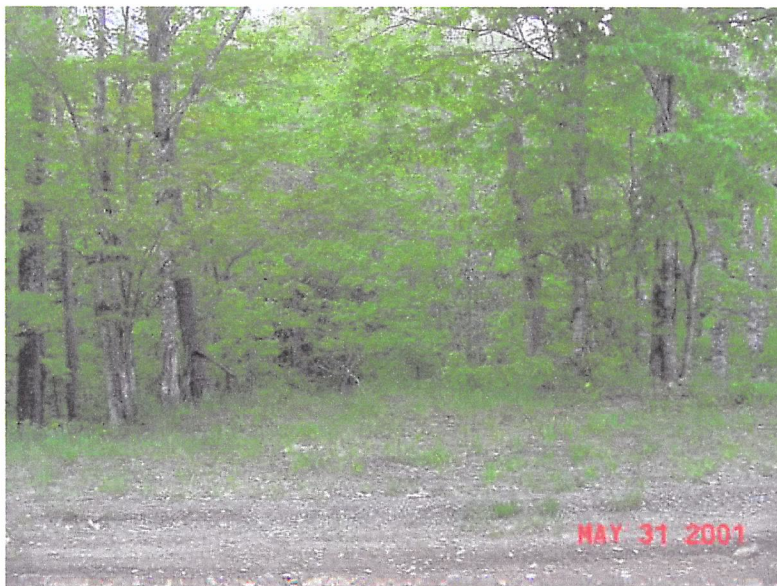
Figure 3.5.2. Upper Halfway Brook showing local woodland

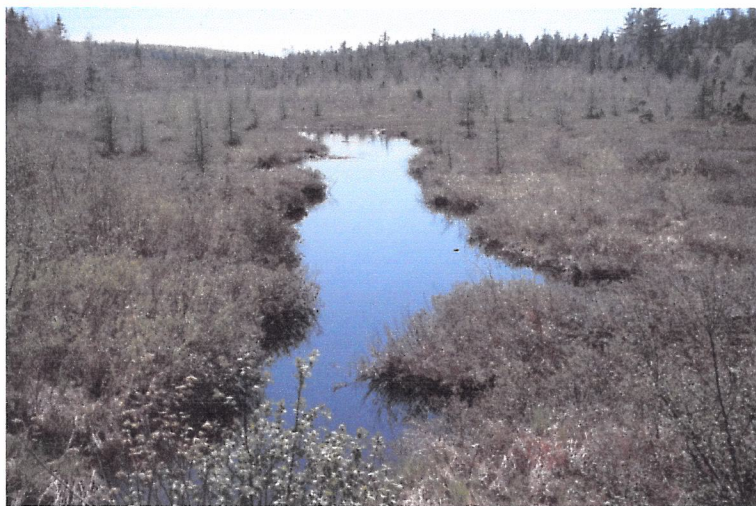
This small stream drains a large bog below Peck Meadow (Figure 3.3.4 and 3.5.3). At the top, where it issues from a culvert, the stream is shallow and meandering (i.e. a flat), mostly covered by riparian grasses and alders, and often largely blocked by debris. The substrate is organically rich and sandy, with very little coarse sediment. The high organic content undoubtedly contributes to low oxygen levels, and this, with the low pH and shallow water level, makes this a rather difficult environment for fish. Nonetheless, brook trout (and eels) were present during the May survey, although none were captured in July. Amphibians, were abundant, especially green (*Rana clamitans*) and pickerel frogs (*Rana palustris*). Although the instream food resources are limited in variety in the uppermost portions of the stream, insects are abundant in the surrounding vegetation, and probably provide adequate food resources.

Figure 3.5.3. Peck Meadow Bog view upstream from HW2.

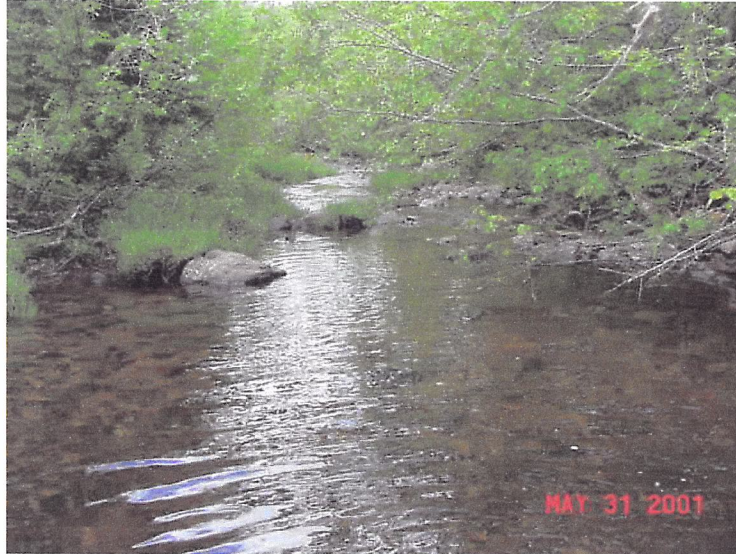
had become completely dry in places, trapping fish in occasional pools and in the sampling reach. Although the biological productivity of this stream appears to be high, the intermittent nature of the water supply limits its fish habitat suitability.

Figure 3.5.4. Gold Brook, looking downstream toward the Halfway River

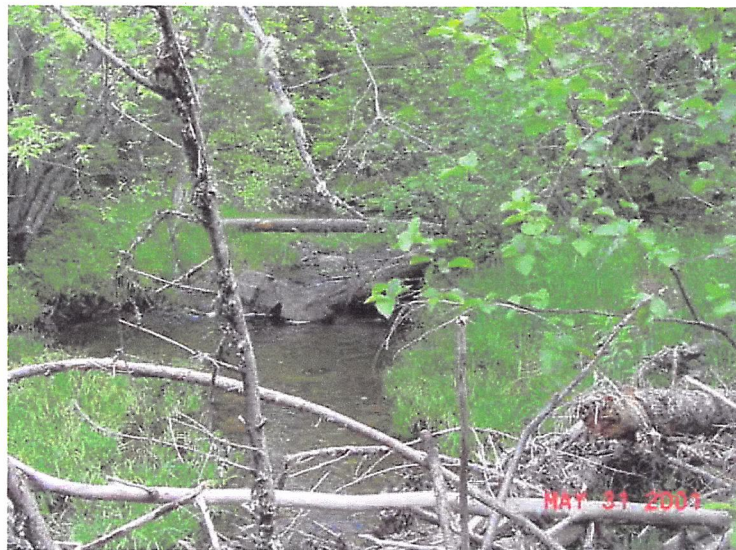
Figure 3.5.5. Gold Brook showing riparian cover

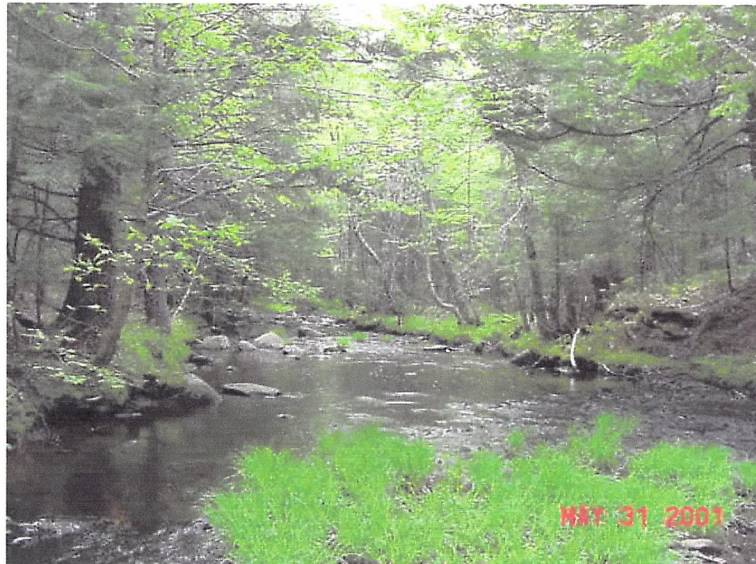
Thompson's Brook was surveyed for almost 400 m, including the reach used for electrofishing. This is a wide, shallow stream (Figure 3.3.6), meandering through variable woodland, and sometimes quite exposed. Unlike Gold Brook, there are few rocky outcrops; substrate tends to be relatively small pebbles and cobbles, often collected into bars forming a braided channel where boulders dominate. Much of the stream flows smoothly, as a run, but riffles occur at intervals, often associated with fine gravel, pebbles and sand.

Figure 3.5.6. Thompson's Brook looking upstream

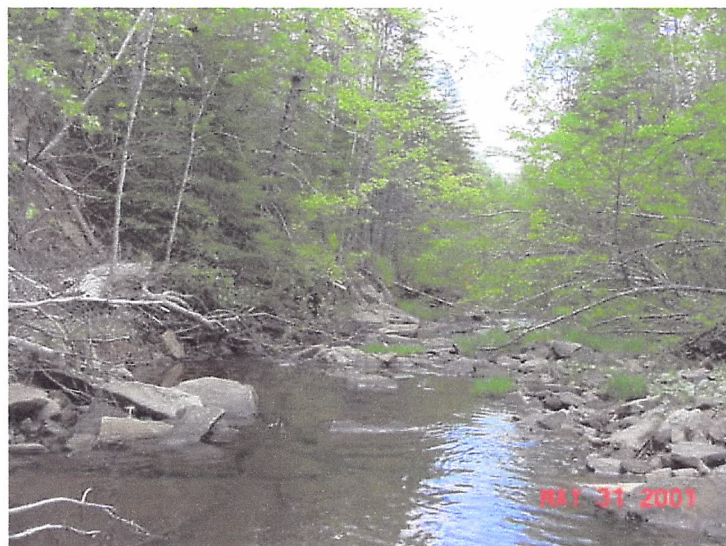
More distant from the bank, the vegetation is predominantly of softwoods, and provides relatively little canopy cover. Some stretches are completely exposed. In the stream itself there are often grassy bars, but the other rocks show little algae or moss growth.

Figure 3.5.7. Kelly Brook, looking downstream along HW5 site.

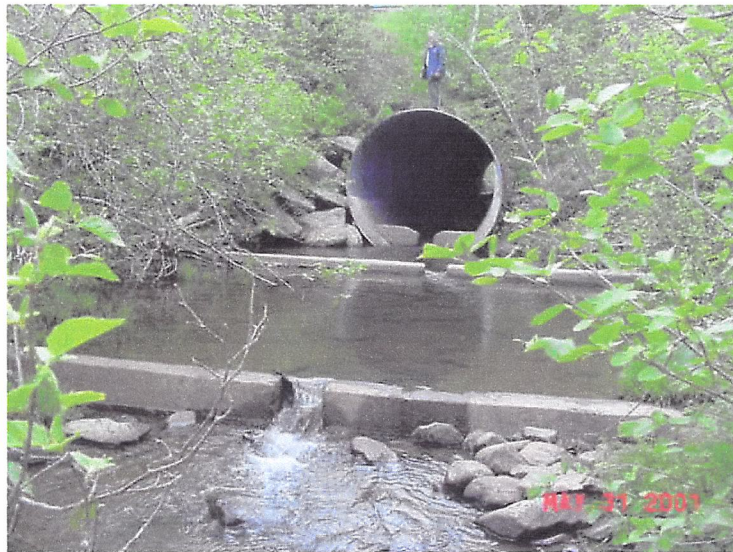
Fig. 3.5.8. Culvert and weir on Kelly Brook

This site is more obviously impacted by human activities than those higher in the Halfway River system. Temperatures during July were sharply higher ($<19.5^{\circ}\text{C}$), and, as noted in Section 3.2, high conductivity (cf. Table 3.2.2) and suspended sediments (Fig. 3.2.1) are probably attributable to the road repair activities going on only a few metres above the electrofishing site (Fig. 3.5.8). During the habitat survey in June, fine sediment was noted as collecting in the weir and in calm areas behind boulders.

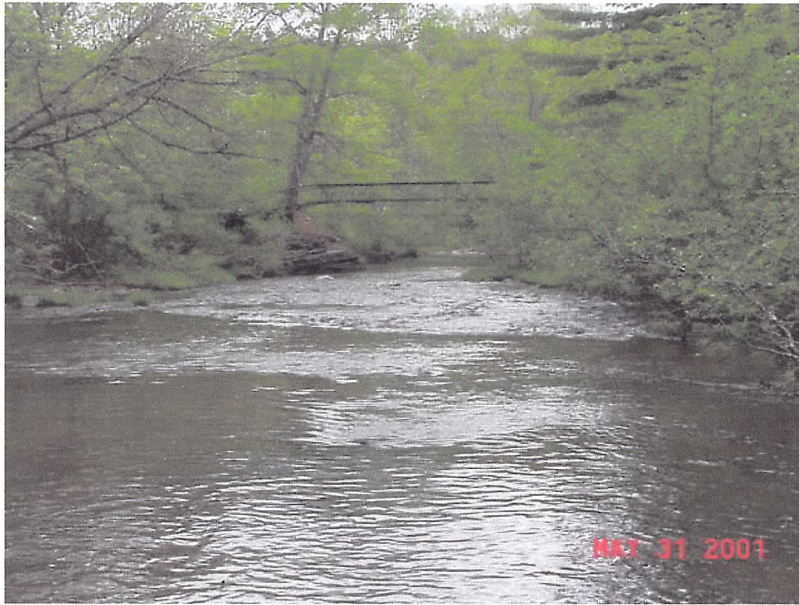
outcropping bedrock with occasional cobble- and boulder-based bars-- stabilised to some extent by alders -- that are overflowed in spring, and dry and grass-covered in summer. Bedrock is primarily blue shale and sandstones, and even during the high spring flows, these seem to be covered with a fine silt. Surrounding vegetation is primarily hardwood (alder, oak, maple, birch) with a few softwoods. Eels and a snapping turtle (*Chelydra serpentina*) were observed during the survey.

Figure. 3.5.9. Halfway River looking toward footbridge

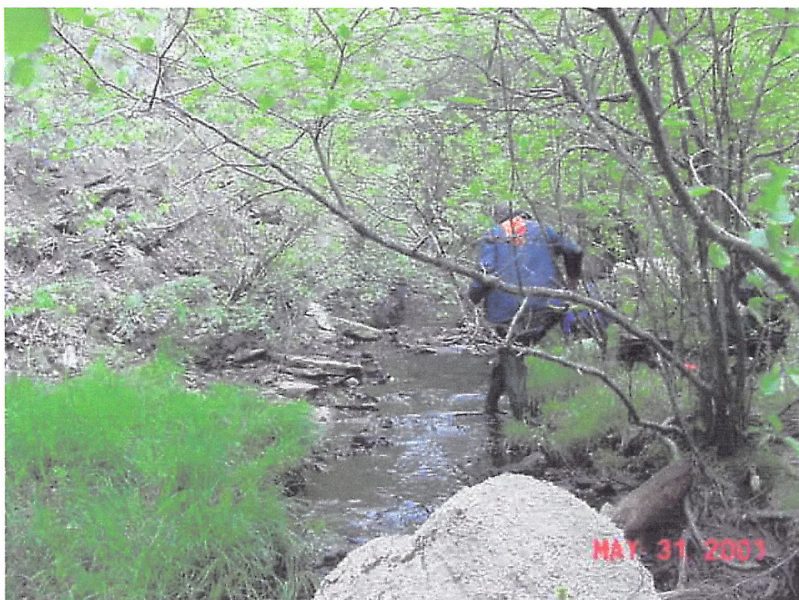
Figure. 3.5.10. Black River showing vegetation and gypsum boulder

Canopy cover is up to 90% in places, with some overhang and instream cover. Substrate is a complex mix of bedrock (mostly slates), gypsum, gravel and even some mud. There is evidence of erosion on some of the softer banks. Further downstream, deadfalls of the surrounding spruces tend to pond up water, increasing depths, and when the stream leaves the defile completely, it becomes more exposed. During the survey a good deal of anthropogenic debris was encountered, and some foam formation noted where the water was especially turbulent. The latter is probably natural plant organics that have been derived from the marsh and woodland on the south side of the highway.

The electrosurvey site began approximately 20 m downstream from a 150 m culvert beneath Highway 101 (Figure.3.5.9), so the survey was conducted for 200 m downstream of the lower end of the fish sample reach. In the upper part of the stream, it is a narrow channel in a sharp defile, with outcropping gypsum rocks and a variety of shale pebbles and cobbles.

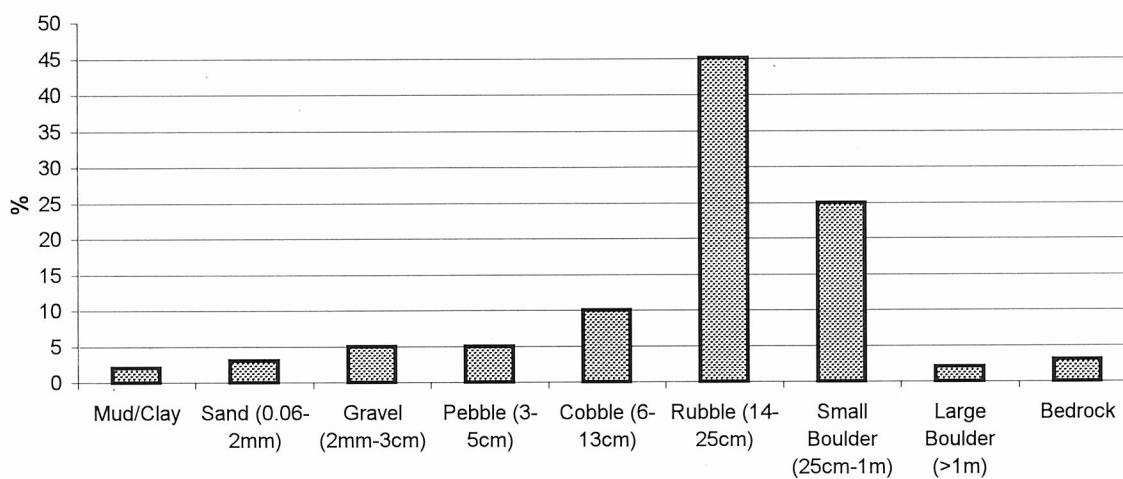
Figure. 3.5.11 Substrate Characteristics for Halfway River Site HW1.

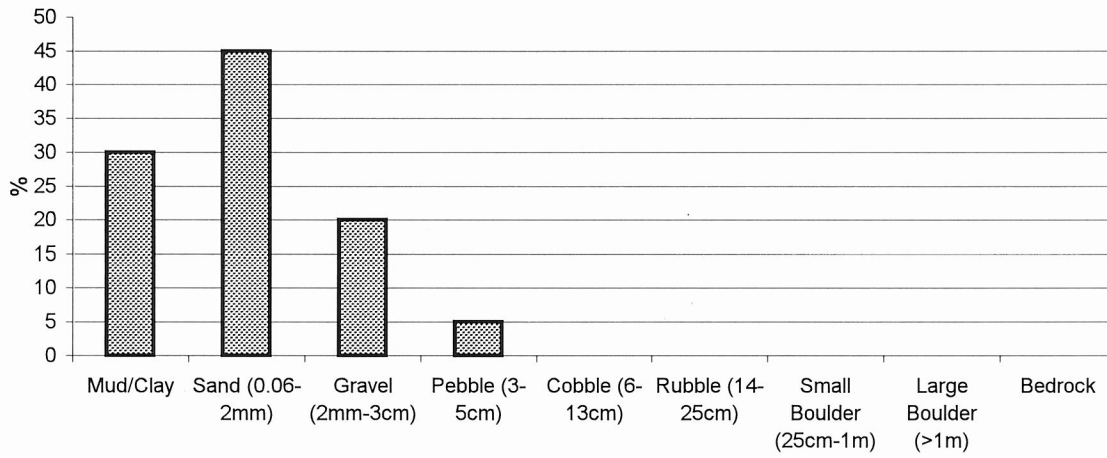
Figure. 3.5.12. Substrate Characteristics for Halfway River Site HW2.

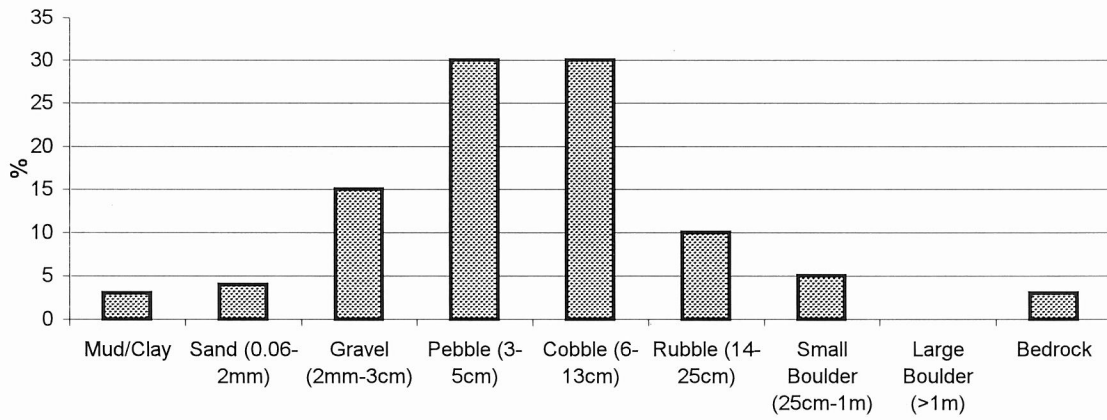
Figure. 3.5.13. Substrate Characteristics for Halfway River Site HW3.

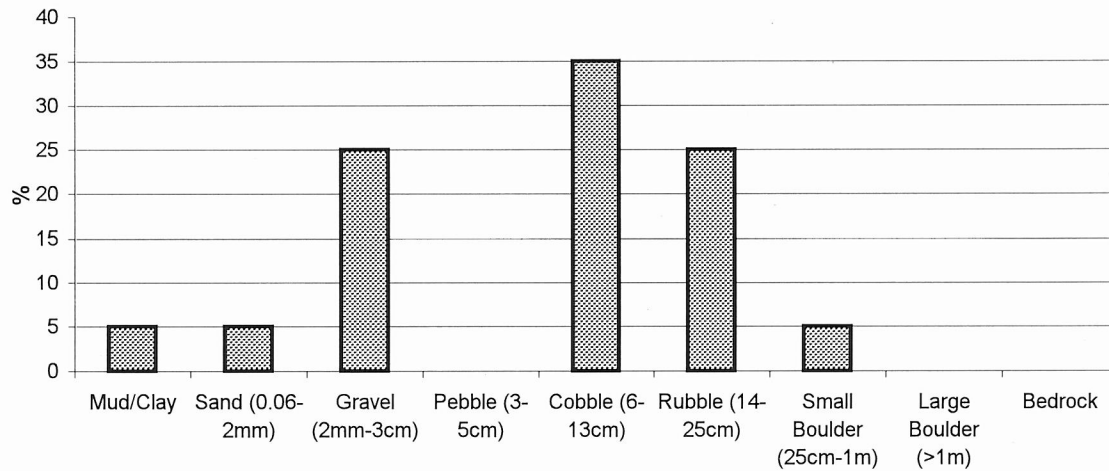
Figure 3.5.14. Substrate Characteristics for Halfway River Site HW4.

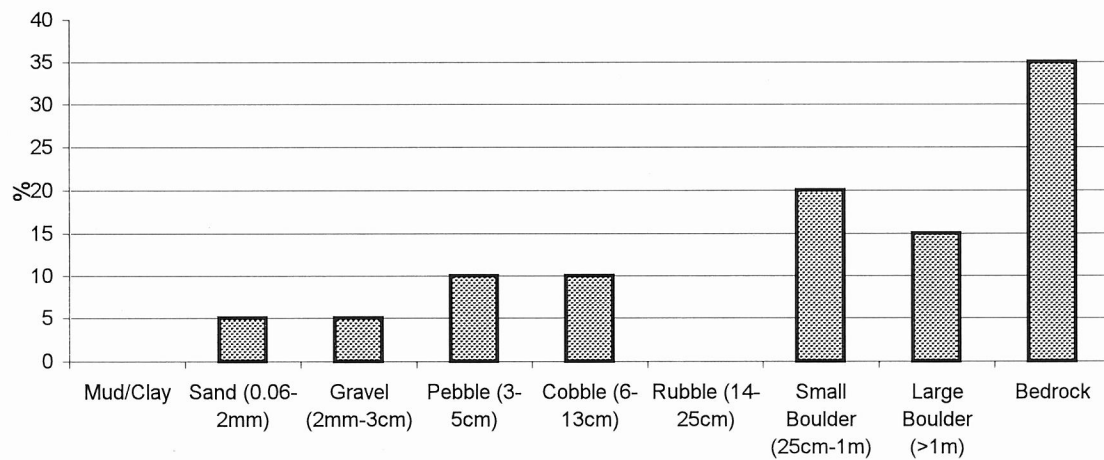
Figure 3.5.15. Substrate Characteristics for Halfway River Site HW5.

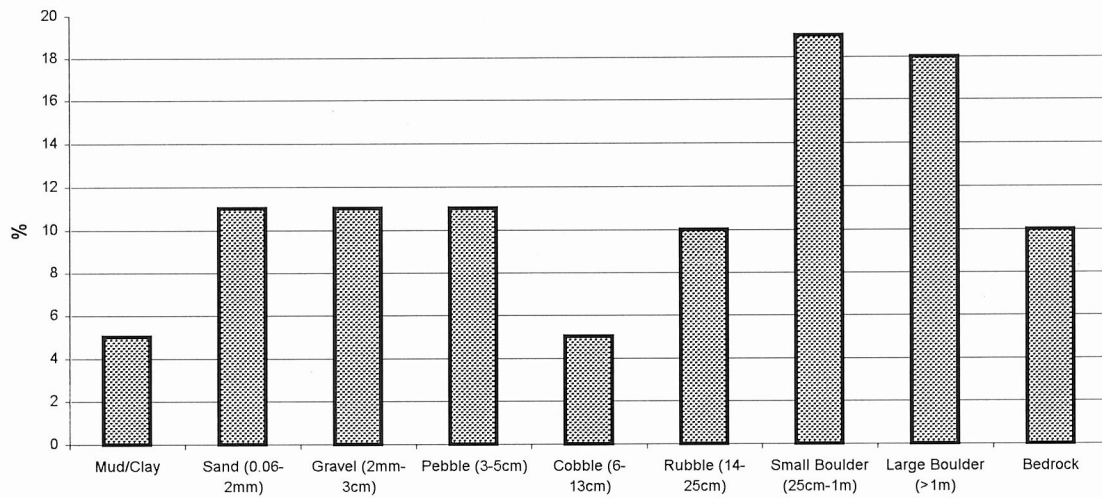
Figure 3.5.16. Substrate Characteristics for Halfway River Site HW6.

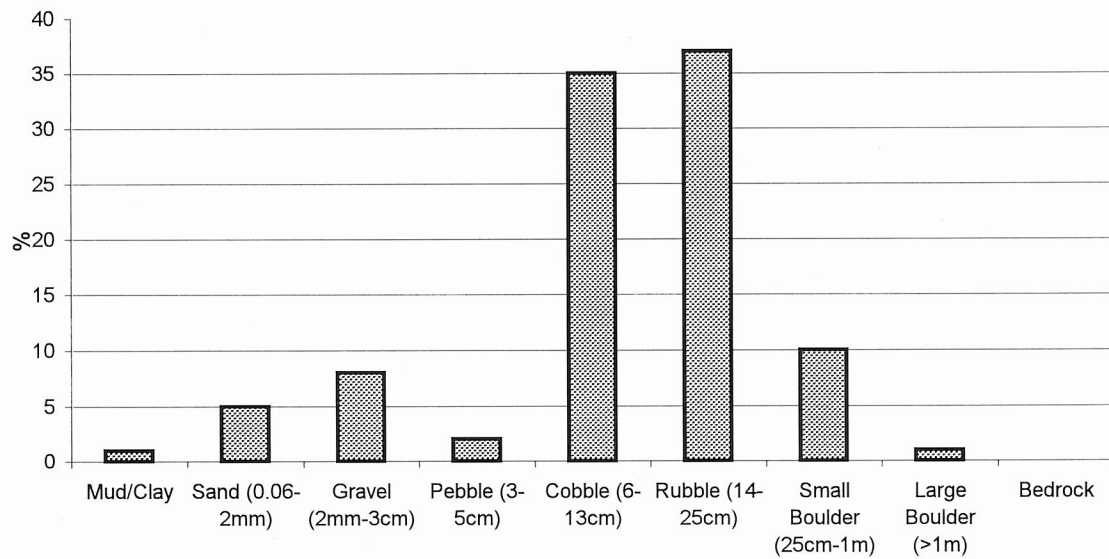
Figure 3.5.17. Substrate Characteristics for Halfway River Site HW7.
