**Environmental Studies of the  
St. Croix River and  
Big St. Margarets Bay Lake Systems  
Nova Scotia**

Final Report  
to  
Minas Basin Pulp and Power  
Company Limited

Prepared by  
Graham R. Daborn, Michael Brylinsky  
and Ruth Newell

September 2001

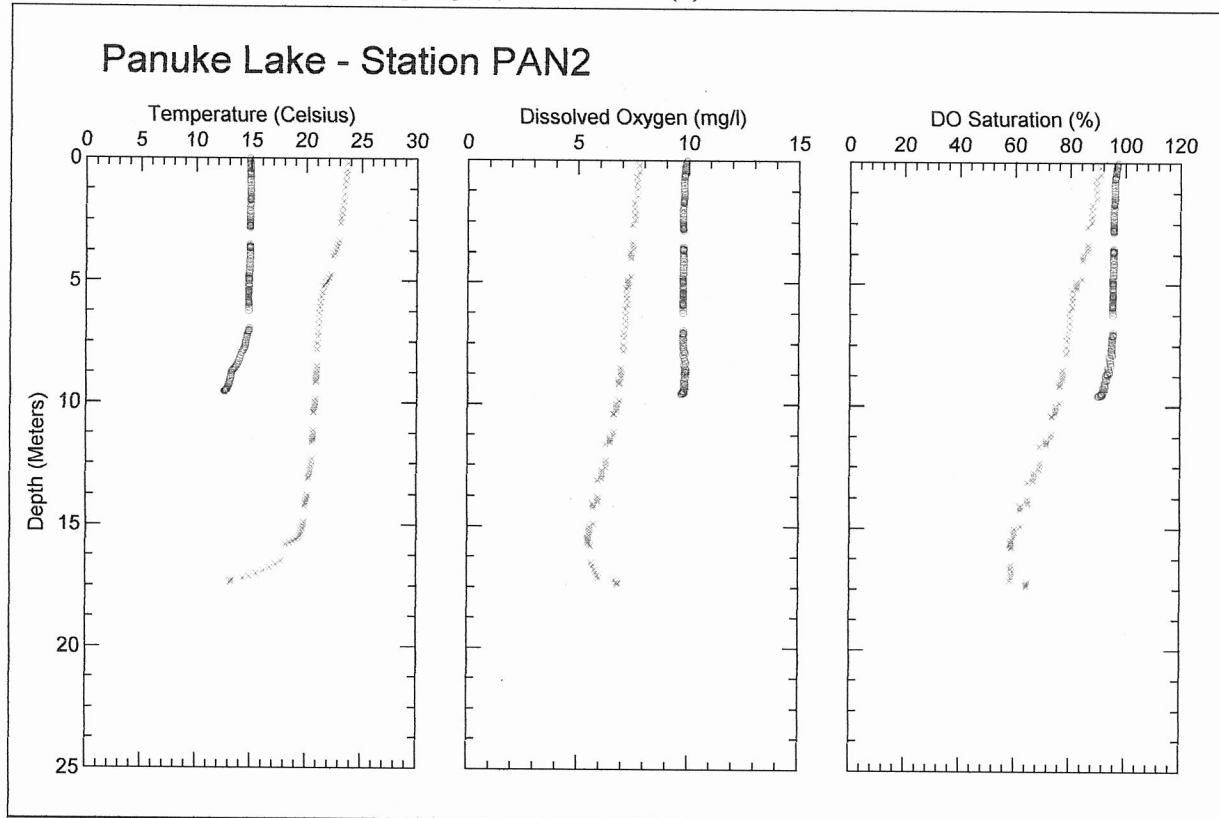
Figure 3.2.5 Temperature, dissolved oxygen and percent dissolved oxygen saturation depth profiles for station PAN2 during spring (○) and summer (x).

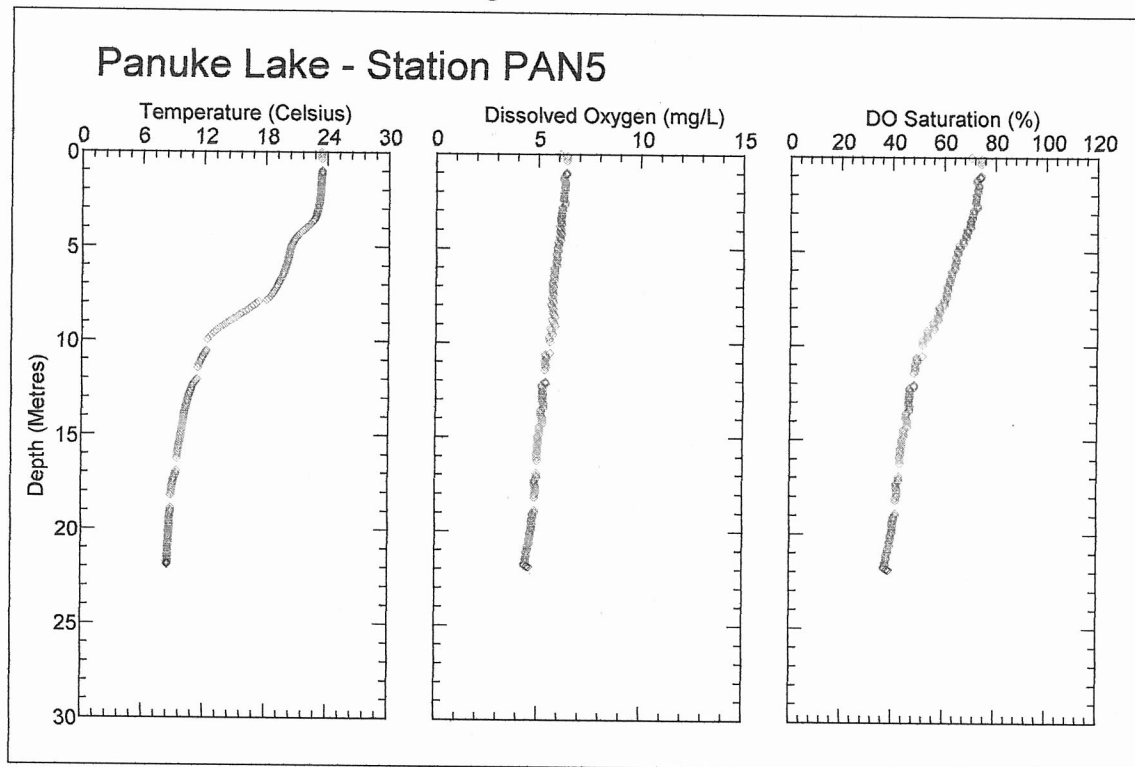
Figure 3.3.9 Temperature, dissolved oxygen and percent dissolved oxygen saturation depth profiles for station PAN5 during summer.

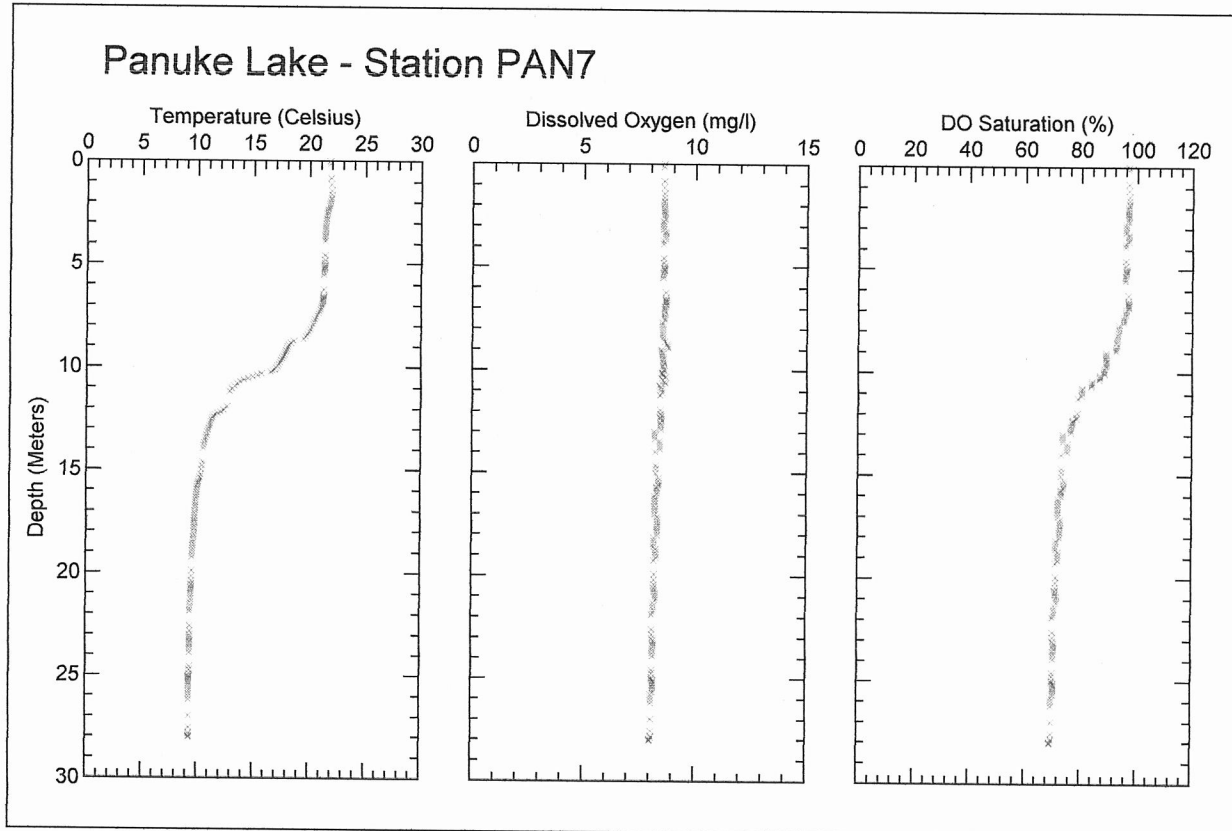
Figure 3.2.11 Temperature, dissolved oxygen and percent dissolved oxygen saturation depth profiles for station PAN7 during summer.

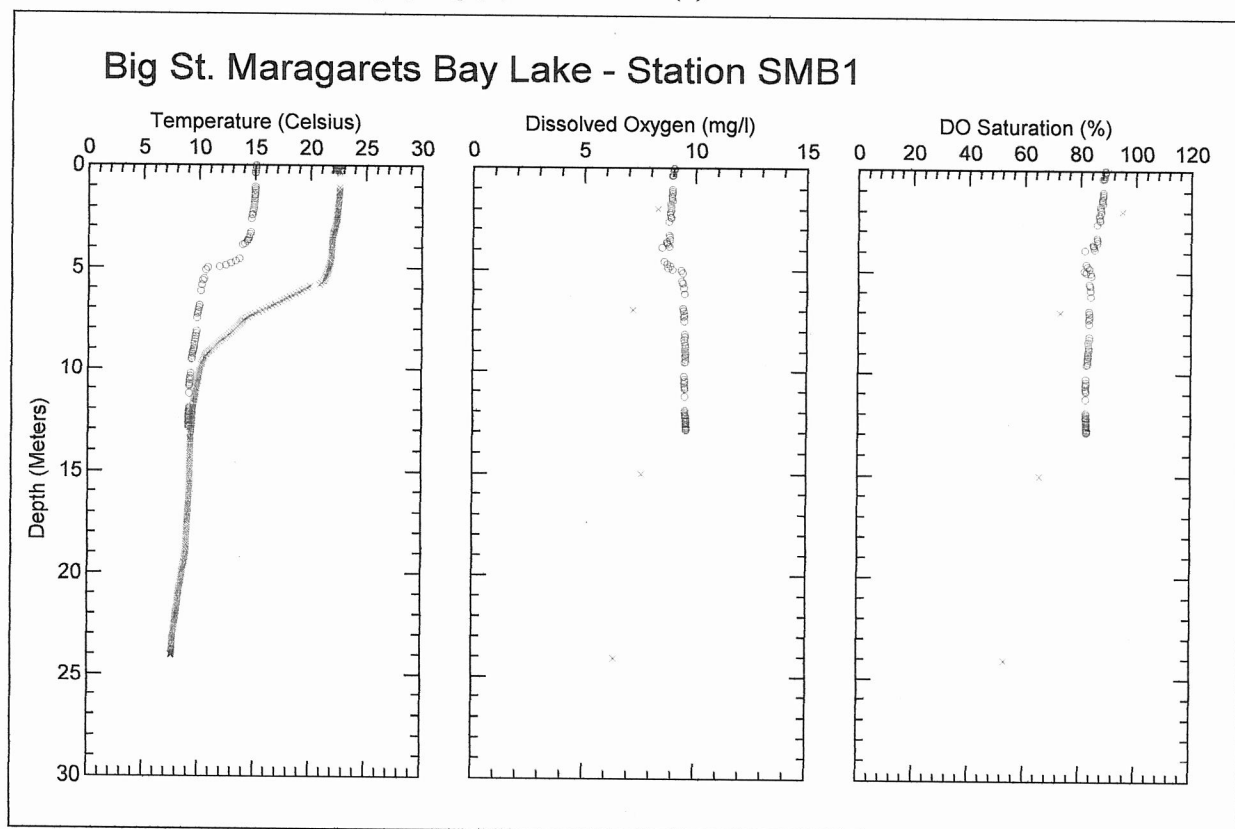
Figure 3.2.12 Temperature, dissolved oxygen and percent dissolved oxygen saturation depth profiles for station SMB1 during spring (○) and summer (x).

Big St. Margarets Bay Lake was strongly stratified during summer with a thermocline between 6 and 9 m (Figures 3.2.12- 3.2.14). The two reservoirs located below the Upper St. Croix (Panuke Lake) dam were quite different from each other. Parsons Dam reservoir stratified very strongly (Figure 3.2.15) whereas the Trash Rack reservoir never became stratified (Figure 3.2.16).

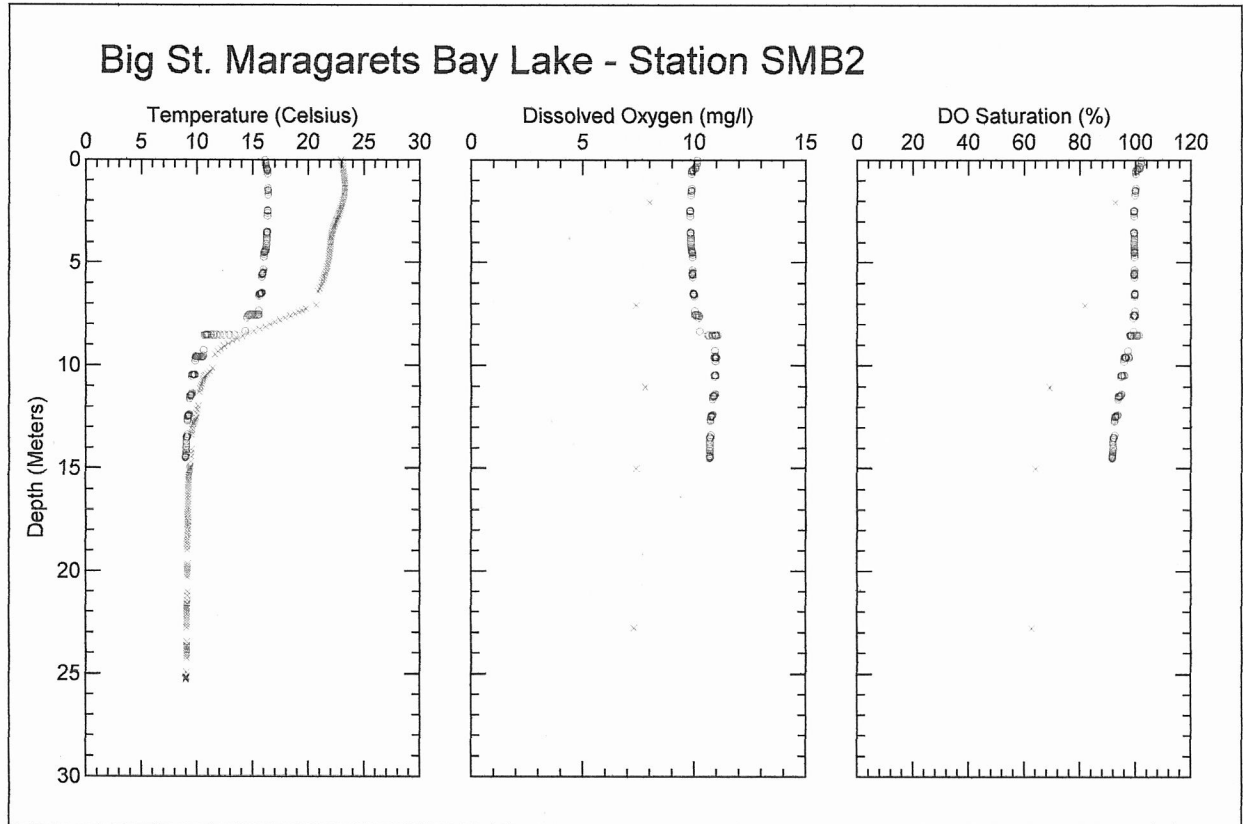
Figure 3.2.13 Temperature, dissolved oxygen and percent dissolved oxygen saturation depth profiles for station SMB2 during spring (○) and summer (x).

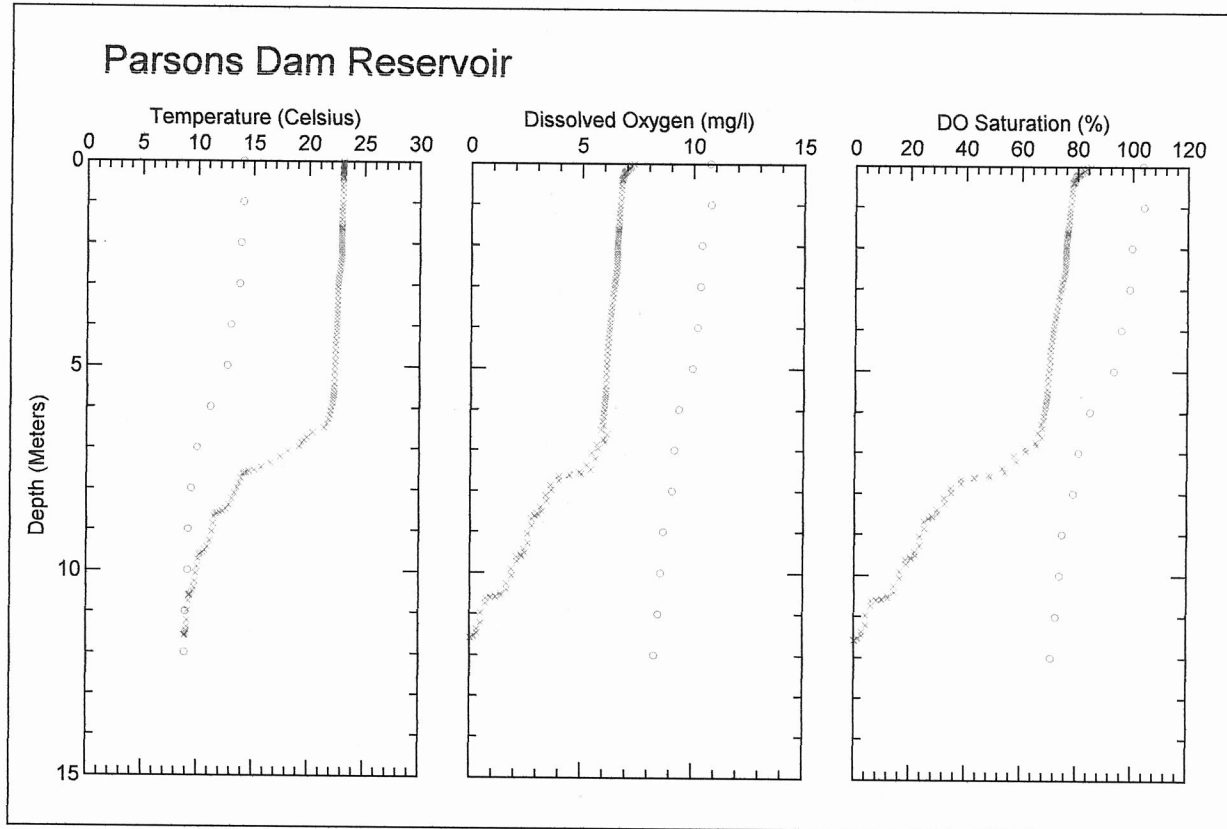
Figure 3.2.15 Temperature, dissolved oxygen and percent dissolved oxygen saturation depth profiles for Parsons Dam reservoir during spring (○) and summer (x).

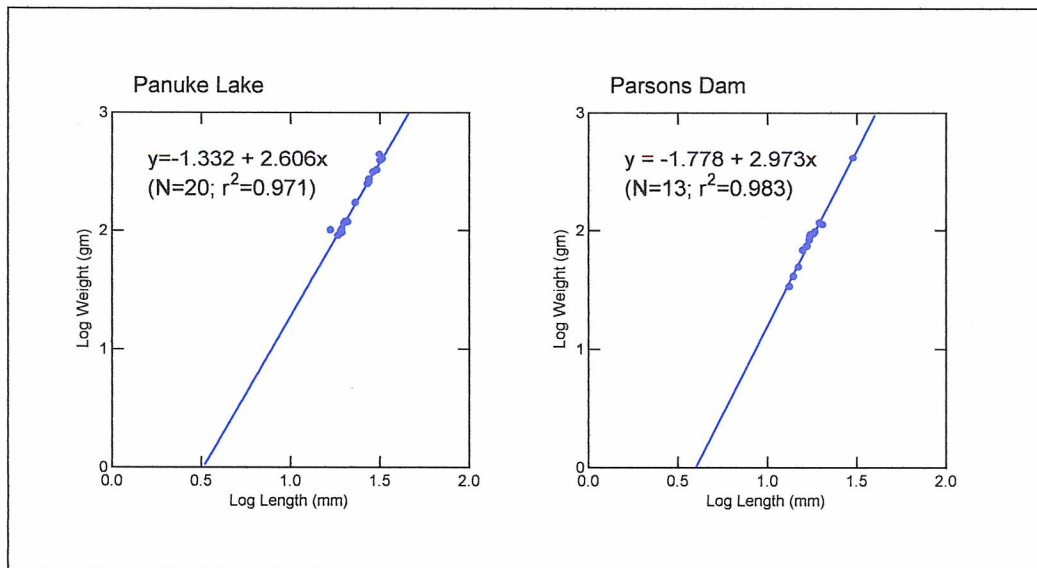
Figure 3.3.16. Length-weight relationship for smallmouth bass.

The length-weight relationships of brook trout, yellow perch and smallmouth bass collected from each impoundment are listed in Table 3.3.3. and illustrated graphically in Figures 3.3.15-3.3.17. For the most part, the slope coefficients are very near three and indicative of fish in good condition.\*

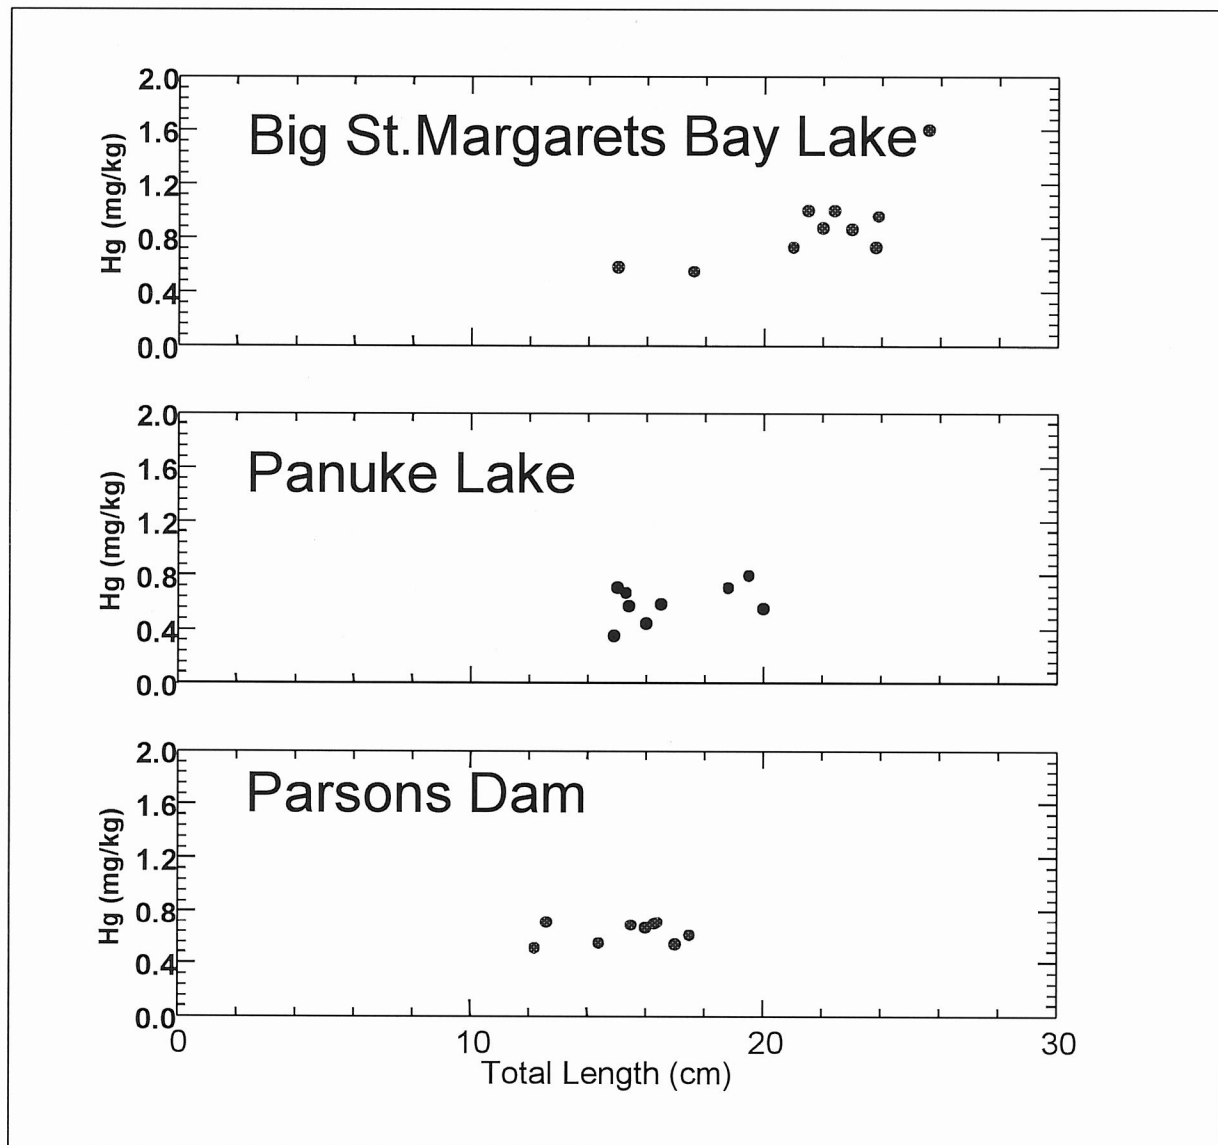
Figure 3.3.19. Relationship between mercury content and size for yellow perch.

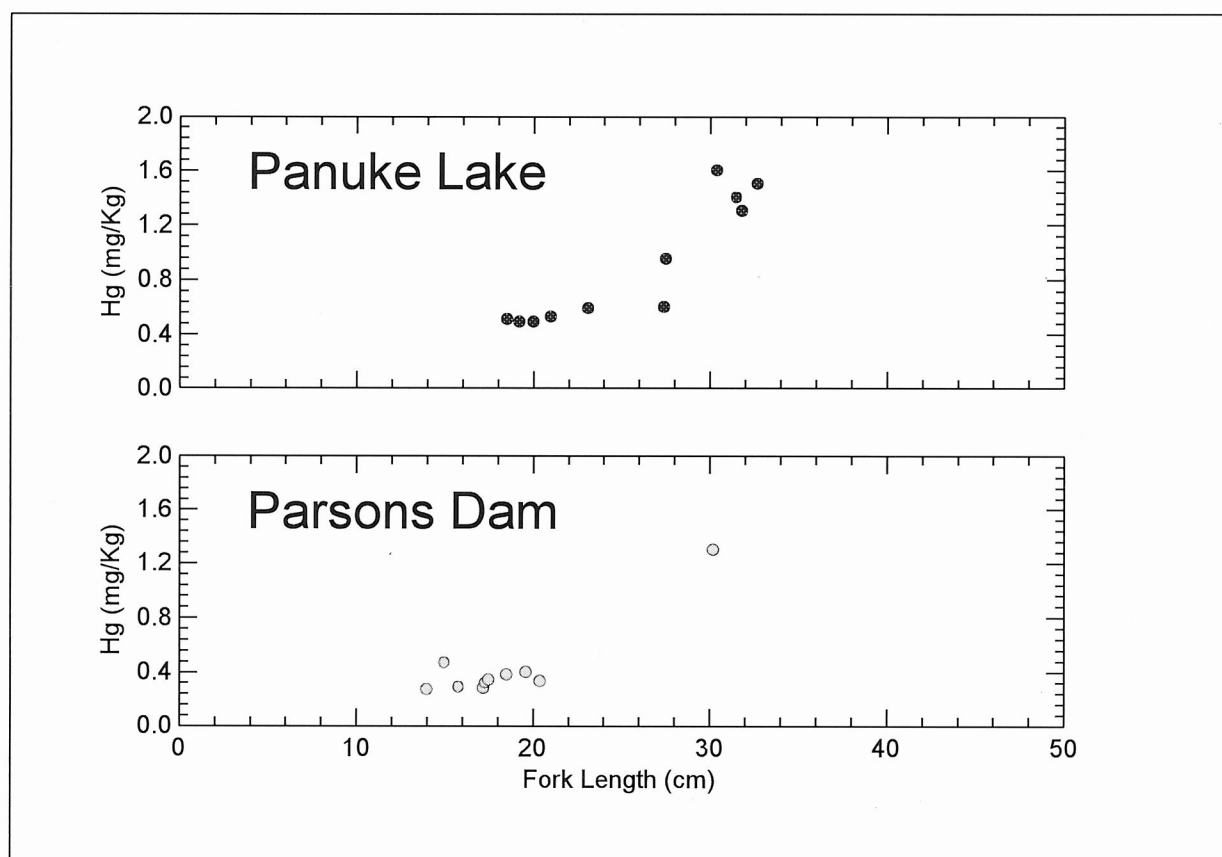
Figure 3.3.20 Relationship between mercury content and size for smallmouth bass.

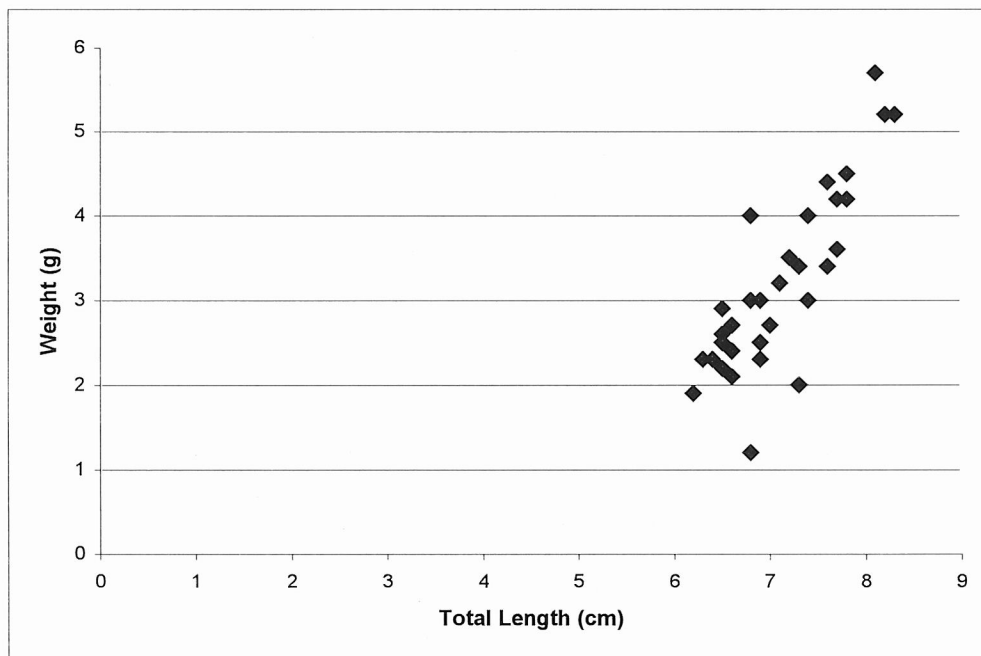
Figure 3.3.22. Length-weight relationships of banded killifish in St. Croix and Big St. Margarets Bay Lake systems

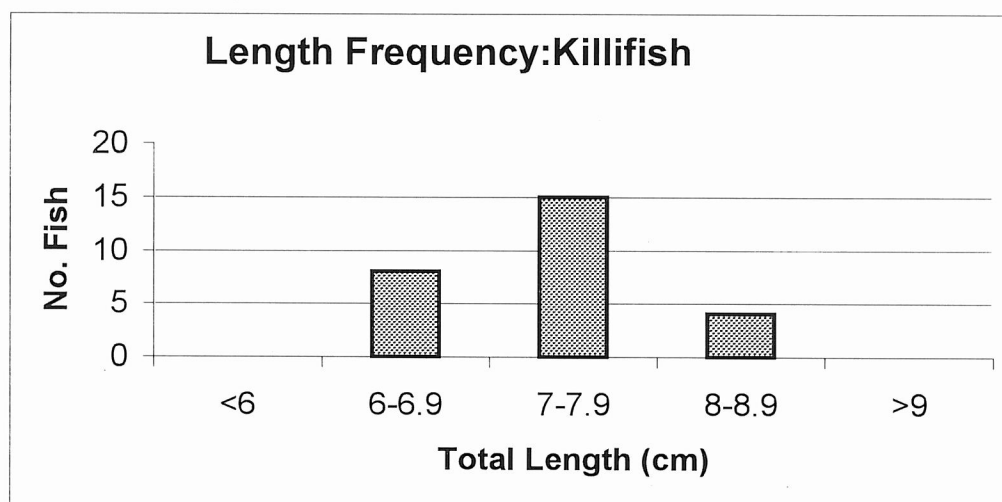
Figure 3.3.24 Length frequencies of killifish in St. Croix and Big St. Margarets Bay Lake systems

Age structures of the populations are indicated in the length frequency diagrams in Figures 3.3.24 to 3.3.26.
