**An Analysis of Factors Responsible for Anoxic Conditions
at Troy Pond, Cape Breton, Nova Scotia**

The Nova Scotia Department of Natural Resources

M. Brylinsky
Acadia Centre for Estuarine Research
Acadia University
Wolfville, Nova Scotia
B4P 2R6

November 2004

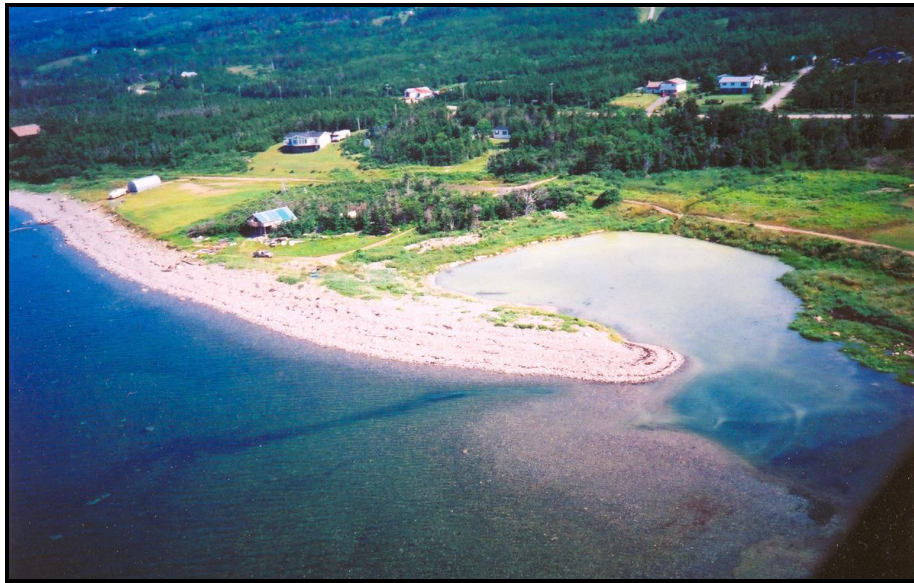
Fig. 2.1. Aerial overview of Troy Pond.

Troy Pond is a small tidal embayment open to tidal exchange with St. Georges Bay (Fig. 2.1). It consists of an outer shallow portion and an inner deeper portion. The outer and inner portions are connected by a narrow sill which separates the two areas at extreme low tides. The maximum depth of the inner pond ranges between about 2 and 3 meters depending on the stage of the tidal cycle. The maximum depth of the outer pond is shallower, ranging between about 1 and 2 meters (Fig. 2.2). Tides in this area are mixed semi-diurnal and characterized by two high and two low tides per day in which successive tides differ substantially in their amplitude (see Appendix I for tide times and heights during the period of this study).

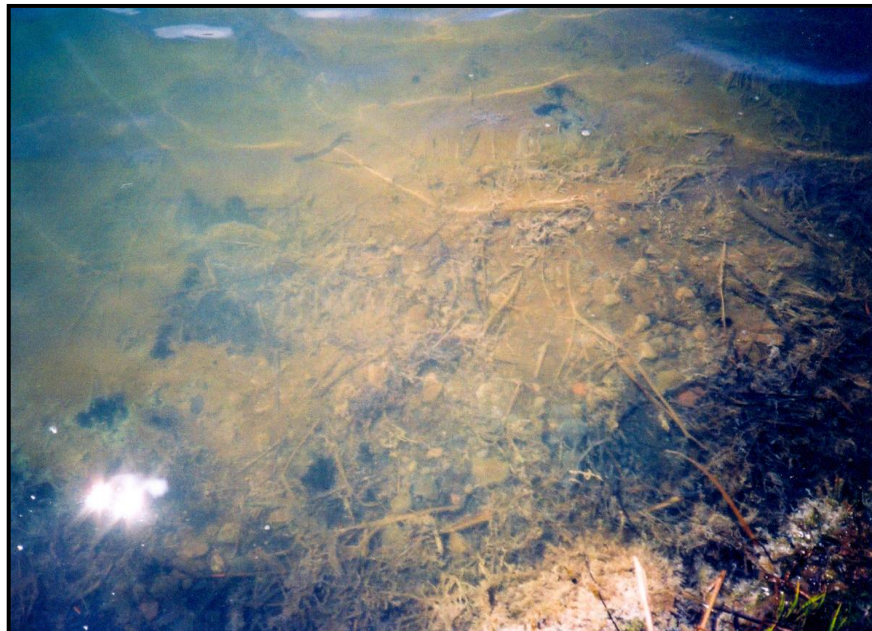
Fig. 2.3. Bacterial mat covering bottom of Troy Pond.

Water within the inner pond is characterized by a milky green color, and a thick, light brown mat of sulphate reducing bacteria covers much of the bottom of the pond (Fig 2.3). The greenish colour of the water is probably due to the presence of anoxygenic phototrophic bacteria, a group of photosynthetic bacteria that can carry out photosynthesis only under anoxic conditions and which do not evolve oxygen. Water within the outer pond, in contrast, is relatively clear and a bacterial mat is not present on the bottom.

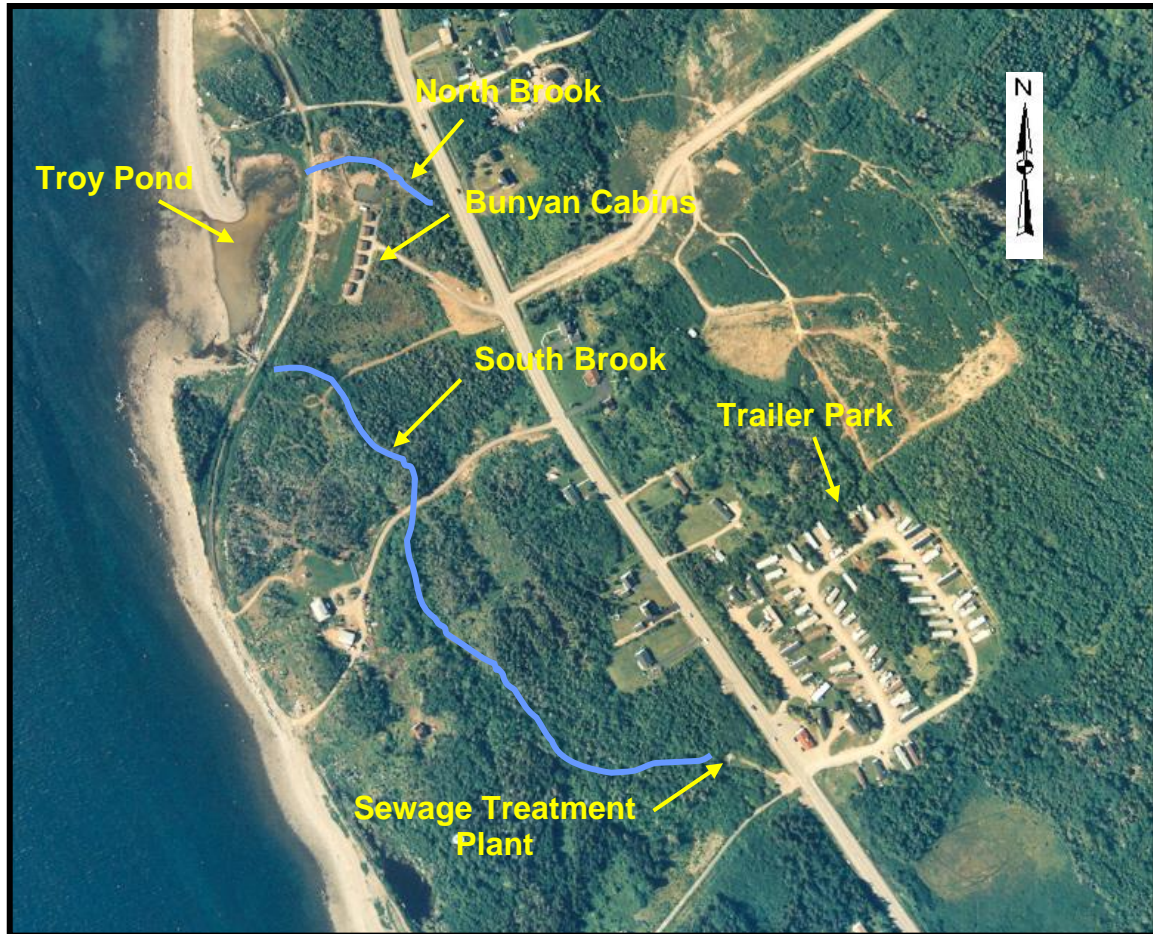
Fig. 2.4. Overview of area surrounding Troy Pond.

Two small streams enter the pond (Figure 2.4). To the north, a persistent spring-fed stream discharges into the inner portion of the embayment. To the south, a larger stream discharges into the outer portion of the embayment. This stream receives effluent from a sewage treatment plant that services a trailer park containing about 50 mobile homes.

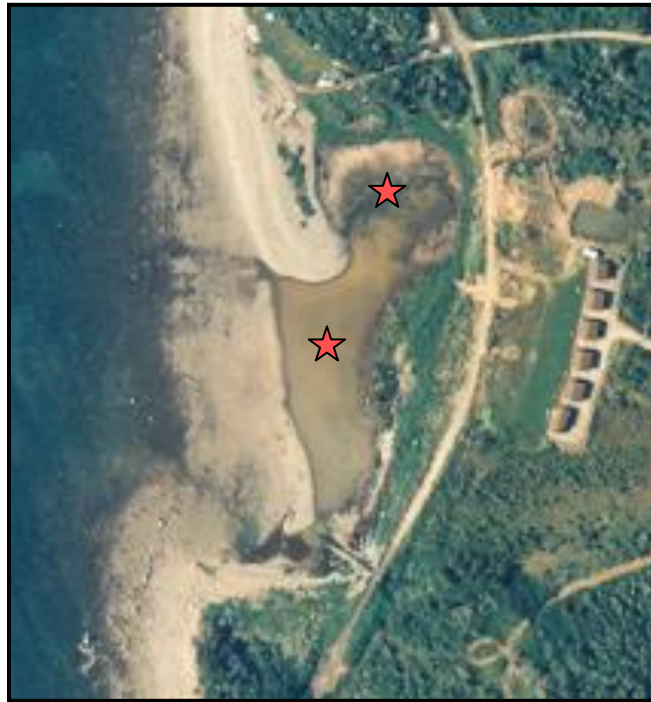
Fig. 4.1. Location of sonde deployments.

Monitoring of the existing situation was carried out using a Yellow Springs Instrument (YSI) Model 9600 multi-probe sonde, programmed to record water depth, water temperature, salinity, and dissolved oxygen concentration at a frequency of every 15 minutes. The monitoring was done over a period of at least 14 days within both the inner and outer portion of the embayment to determine the influence of spring-neap tidal cycle hydrodynamics on variations in water temperature and dissolved oxygen concentrations. The inner pond was monitored from 19 May to 1 June, and the outer pond was monitored from 2 June to 17 June. The locations of the sonde deployments are shown in Fig. 4.1.

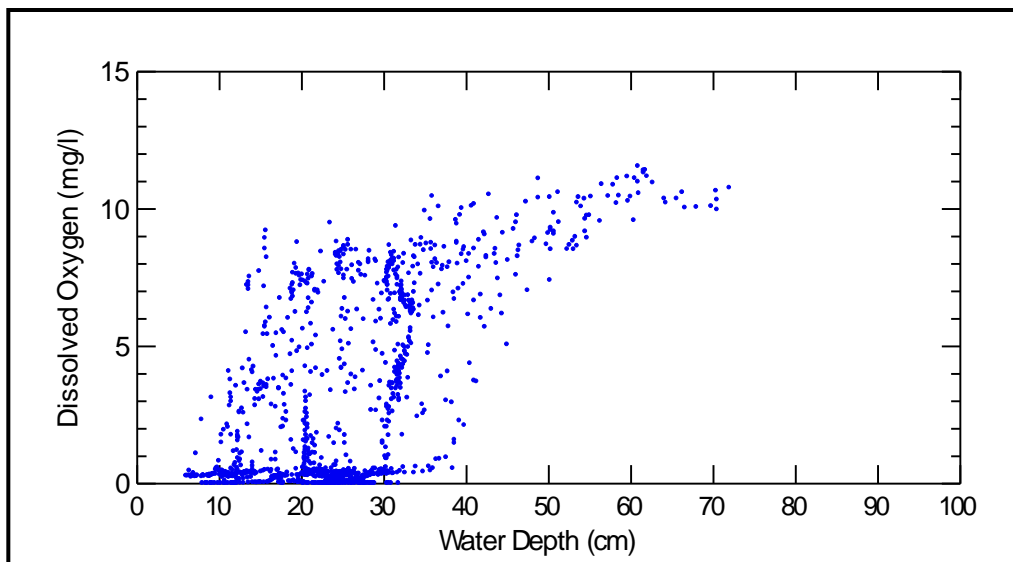
Fig. 5.2. Relationship between dissolved oxygen concentration and water depth at the inner pond.

Time series data was collected at the outer pond between 2 June and 17 June (Fig. 5.3). The outer pond experienced large fluctuations in dissolved oxygen concentrations. Values ranged from a low of 0 mg/L to a high of 11.5 mg/L. The outer pond is much shallower than the inner pond and is flushed much more completely during each tide cycle. Spring tides were in effect during the earlier stages of the deployment and this is reflected by the relatively consistently higher dissolved oxygen concentrations during this period. The latter period of the deployment was dominated by neap tides. At this time the outer pond was less completely flushed and experienced periods of low dissolved oxygen concentrations during each tidal cycle. Figure 5.2 illustrates the relationship between tide height and dissolved oxygen concentration and clearly shows the dependency of the dissolved oxygen concentration on the tidal flushing cycle.

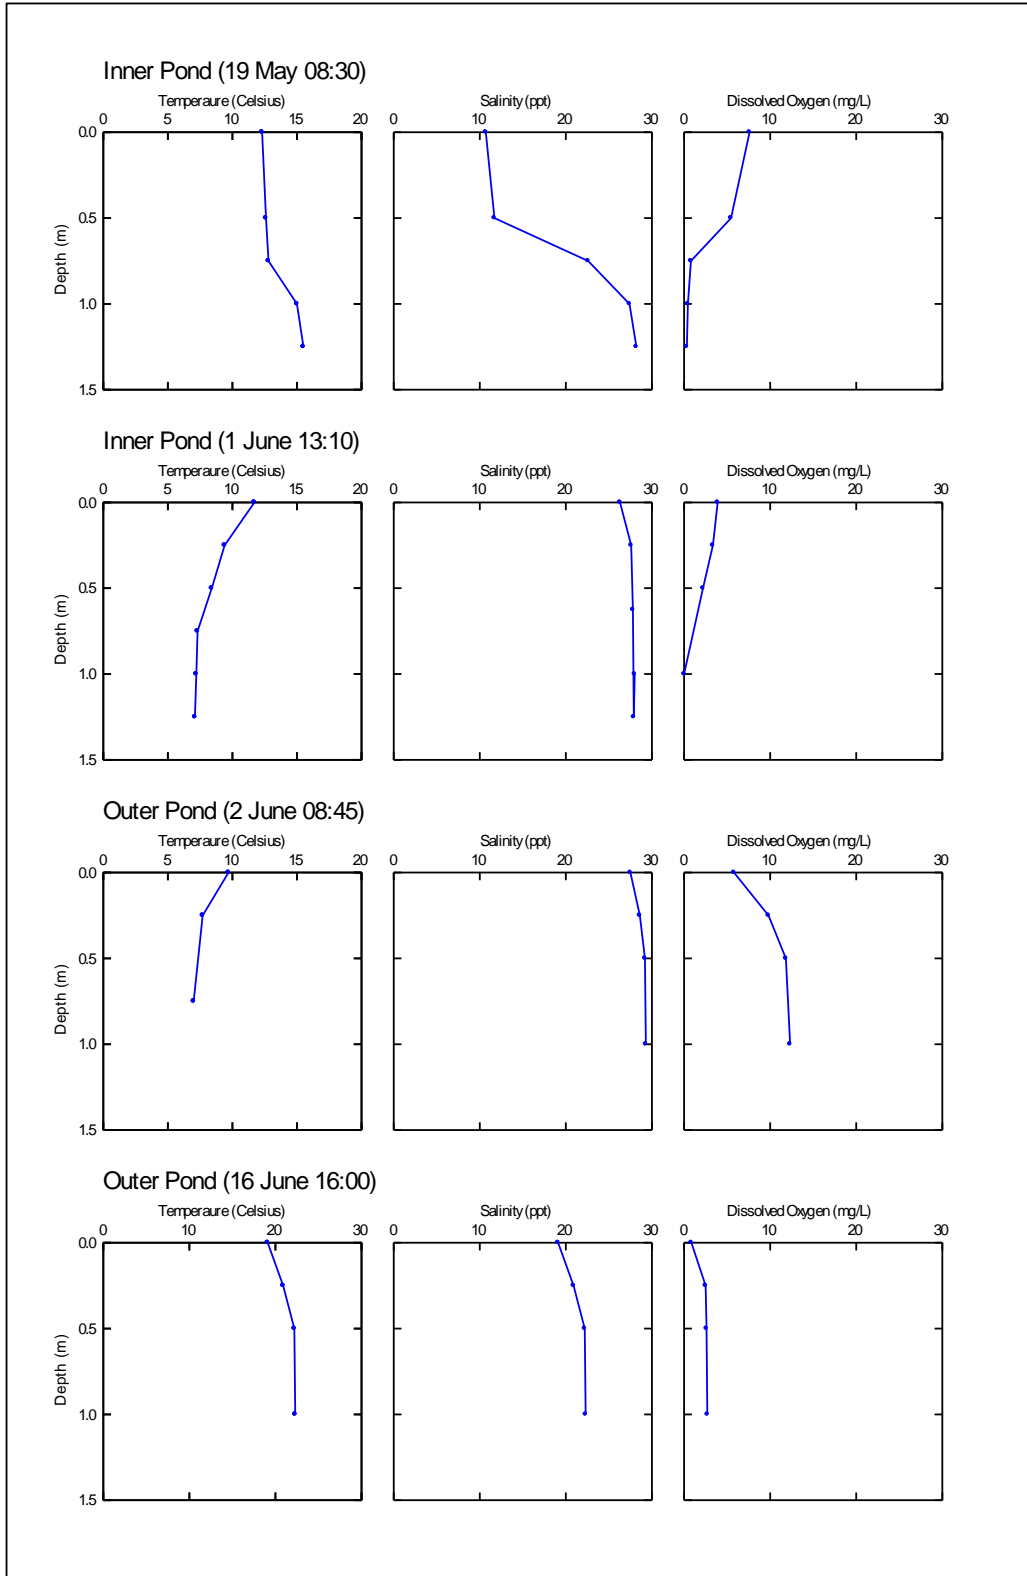
Fig. 5.4. Vertical water column profiles collected at inner and outer Troy Pond during periods of sonde deployment and recovery.

Vertical water column profiles of temperature, salinity and dissolved oxygen, at both the inner and outer pond, were collected during times when the sonde was deployed and recovered. Both ponds showed considerable variation in all of these parameters (Fig. 5.4). At the time of the sonde deployment, the inner pond contained an upper layer of low salinity, cool, oxygenated water overlying a layer of warmer, high salinity, anoxic water. The upper layer most probably represents fresh water from the north, spring fed brook that overlies sea water. This profile was collected very close to high tide. During the time of the sonde recovery, temperature and salinity were much lower and most of the water in the pond was very low in dissolved oxygen. This profile was collected at low tide. The differences in the profiles illustrate that, despite what appears to be considerable exchange of sea water during tidal cycles, there is little increase in dissolved oxygen within the bottom water of the pond. Any dissolved oxygen brought into the pond by either sea water or the North Brook is very quickly utilized in biological decomposition.

The profiles (and time series data) collected in the outer pond suggest that it is much more variable in terms of its dissolved oxygen concentrations. Flood tides transport well oxygenated sea water into the pond, but ebb tides transport low oxygen water from the inner pond to the outer pond. The profile collected at the time of deployment of the sonde coincided with high tide and indicated the presence of cold, high salinity water just below warmer fresher water. The upper warmer layer probably represented water being flushed out of the inner pond. Dissolved oxygen levels were low in the surface water and high in the bottom waters. During recovery of the sonde, the tide was at mid-flood and the outer pond contained warm, anoxic water having a salinity lower than that of the sea water entering the pond. At this time, water within the outer pond was most likely in the process of assuming the characteristics present at high tide during the time of deployment.

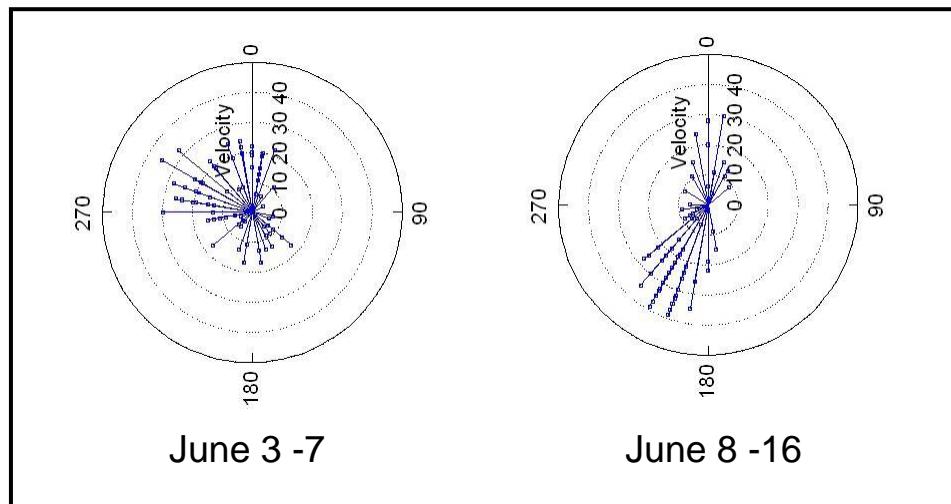
Fig. 5.5. Wind velocity and direction during times when dissolved oxygen levels were high (June 3-7) and low (June 8-16) within the outer pond.

In an attempt to determine the role of wind direction and velocity on the exchange of sea water and aeration of water within the inner pond, hourly wind direction and velocity data for the period during which time series data was collected at the outer pond was obtained for Tracadie, N.S from Environment Canada's climate data website. Fig 5.5 illustrates the differences in wind direction and velocity during times when dissolved oxygen concentrations were high ($>50\%$ saturation) and low ($<50\%$ saturation).

Dissolved oxygen levels tended to be highest when the strongest winds were from the northwest and lowest when the strongest winds came from the southwest. This is most likely the result of storm surge activity. The higher dissolved oxygen concentrations would result from the movement of well oxygenated offshore water into the pond by the onshore northwesterly winds. In contrast, the southwesterly offshore winds would tend to lessen the amount of offshore water entering the pond.

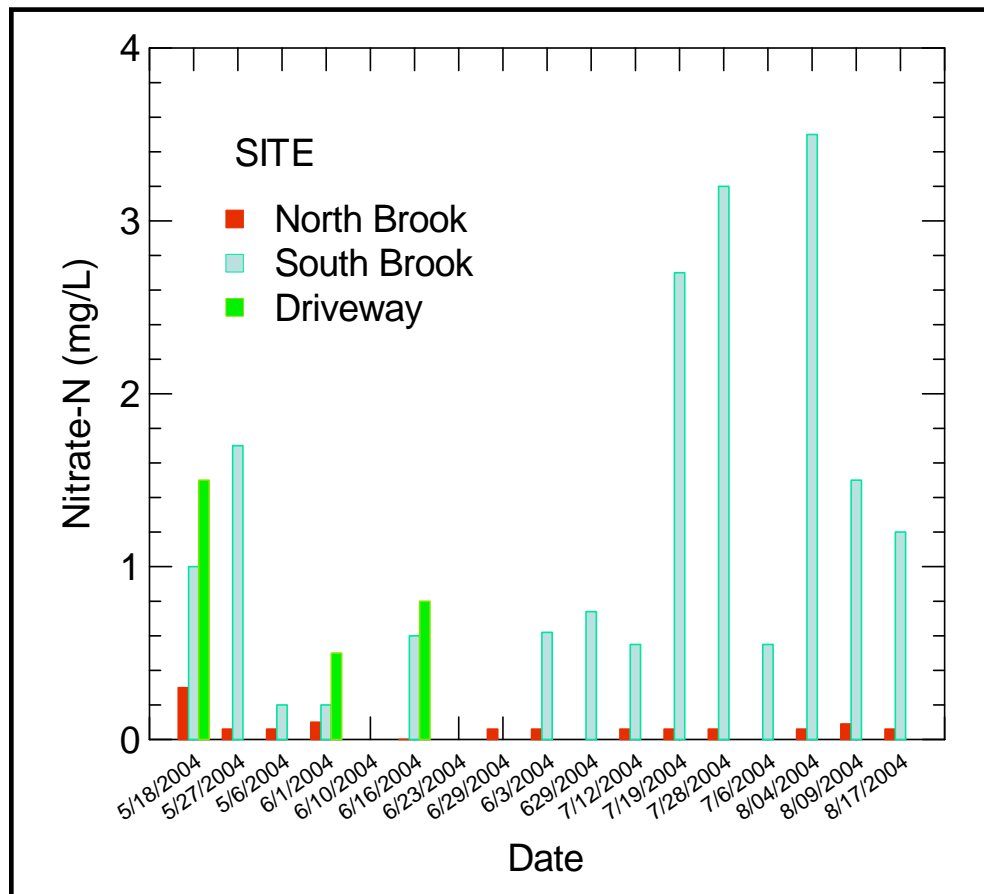
Fig. 5.6. Temporal variation in nitrate-N concentrations at the three brook sites.

The results of the nitrate measurements are summarized in (Appendix II) and Fig. 5.6. When measured concurrently, nitrate concentrations were relatively low (<0.5 mg/L) in the North Brook and high (>1.0 mg/L) in the South Brook.

On those occasions when nitrate was measured at both the Lower and Upper South Brook (Driveway) site, nitrate concentrations were always greater at the Upper South Brook site. The source of this nitrate is undoubtedly the sewage treatment plant servicing the mobile trailer park. The lower values at the Lower South Brook site indicate that the South Brook does have the capacity to assimilate some of the nitrate discharged from the sewage treatment plant before it enters the outer pond.

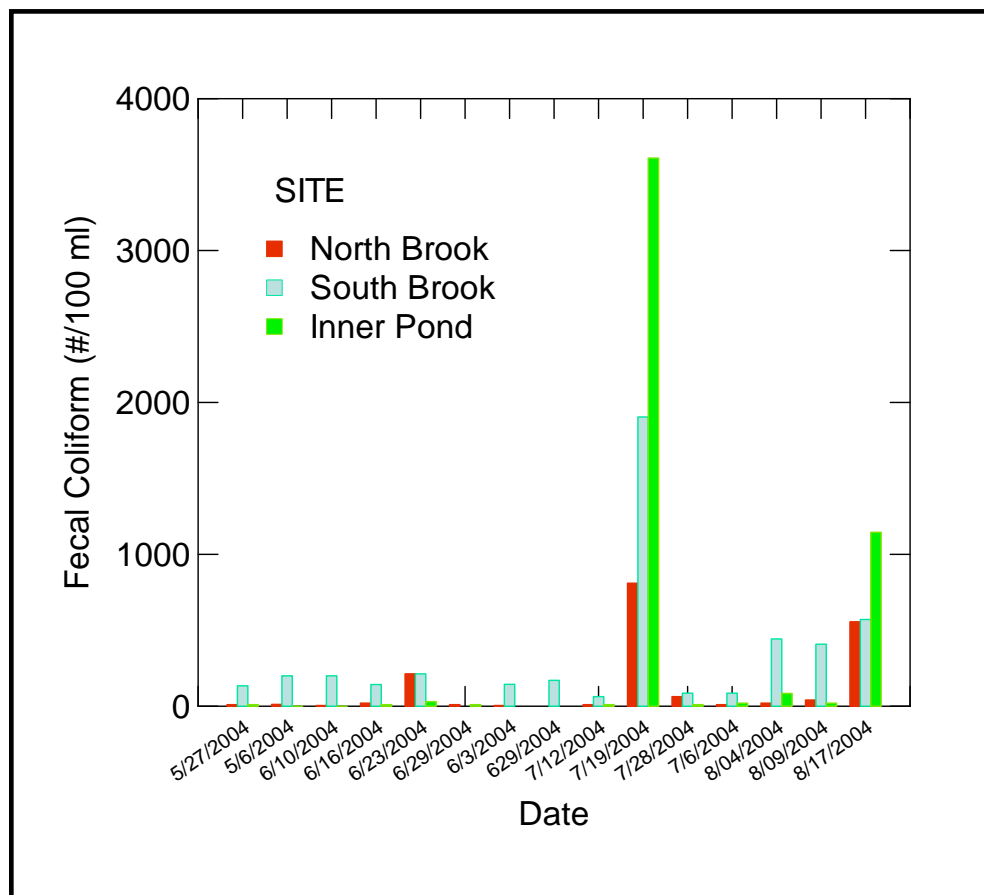
Fig. 5.7. Temporal variation in fecal coliform numbers at the two brook sites and the inner pond.

The results of fecal coliform numbers (Fig. 5.7) generally followed the same trend as nitrate concentrations at the two brook sites. They were lowest in the North Brook and highest in the South Brook. Within the inner pond, coliform bacteria numbers were generally the lowest of all sites except on two occasions when coliform numbers were very high at all sites. The latter is difficult to explain based on available data.

These results indicate that waste materials from the sewage treatment plant discharging into the South Brook do enter the pond.
