**Results of a Preliminary Survey of the Seabed at a Site Proposed for
Deployment of a Tidal In-Stream Power Turbine in the Minas Passage of the
Bay of Fundy**

Nova Scotia Power Inc.

Michael Brylinsky
Acadia Centre for Estuarine Research
Acadia University
Wolfville, Nova Scotia
B4P 2R6

January 2008

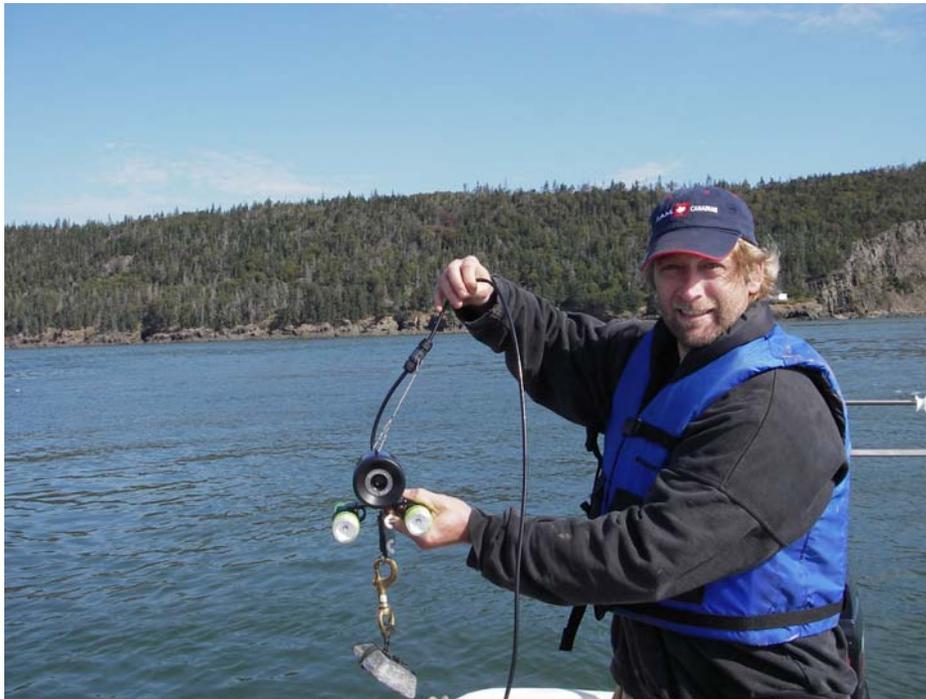
Figure 2. Video camera used for benthic survey.

Previous experiences in the Bay of Fundy indicated that the most commonly available ROVs are difficult to control and, because of their light weight and large size, can not be adequately directed in areas having high current velocities. For that reason a small drop and tow underwater video camera* that could be weighted was used (Figure 2). This system included a high resolution video camera equipped with an auxiliary lighting pod, a ship board LCD monitor, and a video recorder linked to a GPS receiver that recorded both position and time directly onto the video record. All of this was connected through a 75 meter long umbilical cord that also served as the tow line.

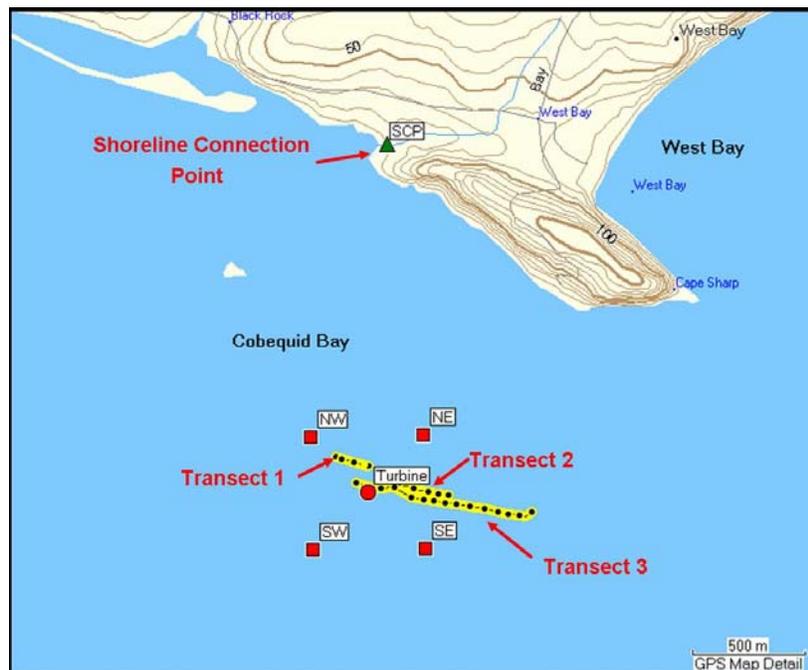
Figure 4. Location of video transects for surveys carried out on 3 October 2007.

As a result of the difficulties experienced in deploying the video camera in deep water, the 3 October survey was carried out at low tide (the 27 September survey was carried out at high tide). The shallower depth at the proposed turbine site resulted in greater success in obtaining a video record of the seabed. Three transects were surveyed (Figure 4) and video recordings were made at each (Titles 1, 2 and 3 on the DVD). The details of each transect are listed in Table 1. Although the video records are much better than those obtained during the 27 September survey, it is still difficult to interpret the type of substrate and biological community present, largely due to difficulty in controlling the speed at which the video camera moved over the seabed due to the high current velocities. Much of the bottom in this region appears to be composed of small cobble devoid of any attached organisms, but there are also some regions present that contain larger cobble and small boulder-sized rocks colonized by bryozoans, sea anemones, encrusting sponges and barnacles. Sea stars are also present, but there does not appear to be any plant life at these depths.
